# **VILLAGE OF CREMONA**

## **PUBLIC WORKS SHOP & WATER TREATMENT PLANT**

### **BUILDING CONDITION ASSESSMENT**

**Date: May 8, 2026**

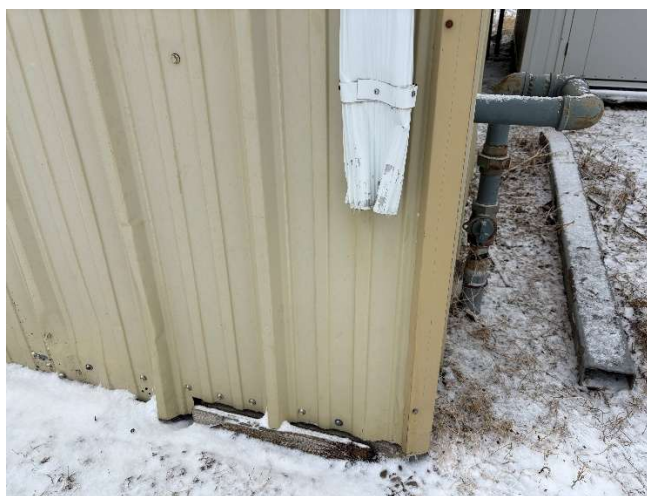
The Main WTP Building roof slopes towards the east and west sides of the building. An eavestrough runs along the roof on the east and west building which directs water to downspouts at the south corners of the building. The downspout at the southwest corner of the building is not fitted with a downspout extension to direct water away from the building foundation. The downspout itself at this corner of the building is also heavily damaged with denting closing the end of the downspout.

**Figure 14: Main WTP Building Missing Downspout Extension**

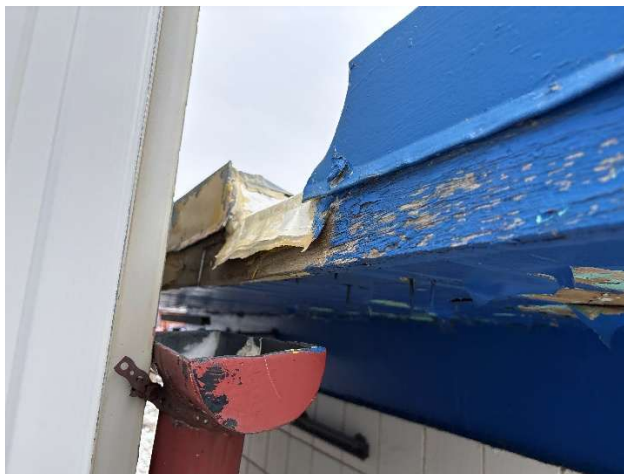
The Bulk Water Distribution Building has a relatively flat roof with an angled parapet board around the perimeter to direct roof runoff to an opening and downspout on the north side of the roof. The roof drainage system overall does not appear to be effective in directing runoff from the roof away from the entrance and building foundation.

**Figure 15: Bulk Water Distribution Building Roof Drainage System**

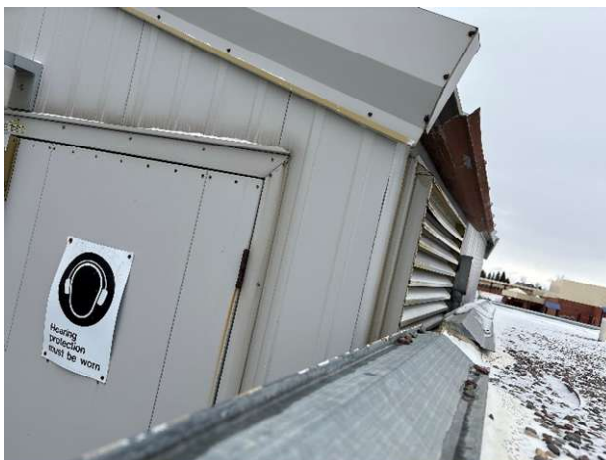
The Generator Building roof slopes to the north and south with a partial eavestrough running along the roof on each side. No downspouts or downspout extensions were identified to continuously carry roof runoff away from the building foundation. There does appear to be a parapet fascia on the east and west ends of the building to prevent roof runoff from obstructing the building entrance.

**Figure 16: Generator Building Roof Drainage System**

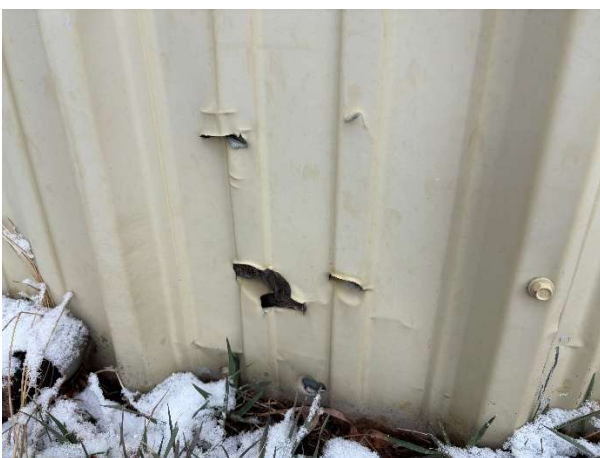
Figure 17: Main WTP Building Cladding Penetrations

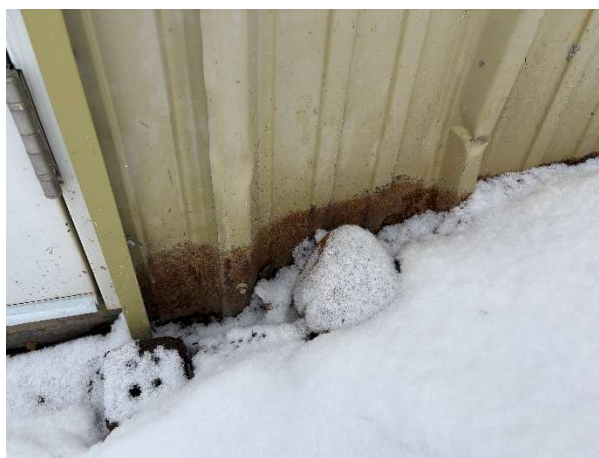
The pre-finished corrugated steel roof cladding on the Main WTP Building was difficult to observe due to accessibility limitations. It is reasonable to consider the roofing to be in fair condition based on the condition of other building cladding elements. The pre-finished steel fascias on the north and south faces of the building are in good condition. The pre-finished corrugated steel wall cladding is generally in poor condition with large sections of staining, penetrations, and paint fading. The wall cladding on the east face of the building is in fair condition and looks to have been replaced in the last 5-10 years. At the bottom of the north, south, and west walls, some instances of cladding corrosion were identified.

Figure 18: Main WTP Building Cladding Corrosion

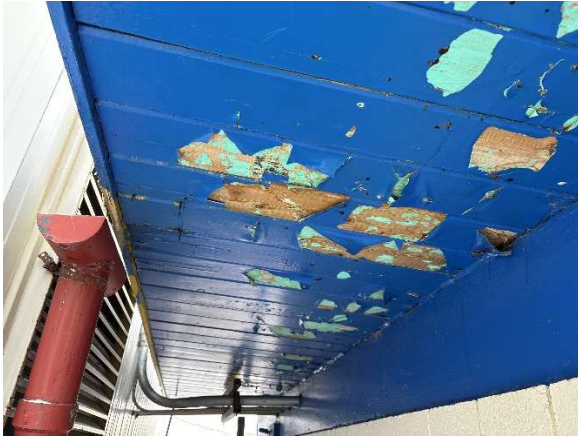
The Bulk Water Distribution Building gravel roof was not assessed in detail due to limit access. It is probable that the gravel roof is in poor condition as some plant growth could be observed from ground level. The painted wood fascias and soffits are in poor condition as paint is flaking substantially. The CMU block walls are stained or scuffed in many instances around the building exterior.

**Figure 19: Bulk Water Distribution Building Wood Soffit Paint Flaking**

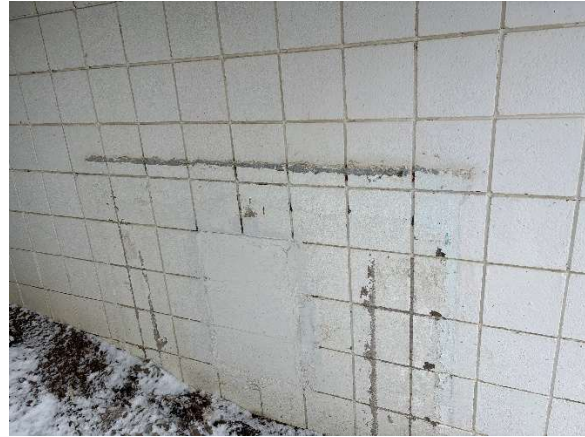
**Figure 20: Bulk Water Distribution Building CMU Block Wall Scuffs**

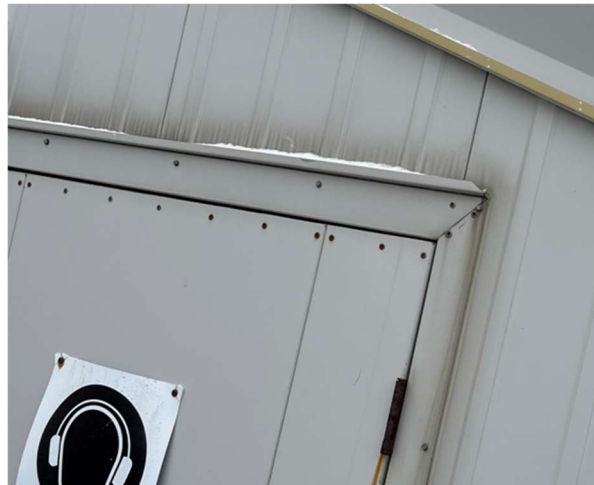
The Generator Building steel roofing was not assessed as access was not permitted at the time of inspection. It is probable that the steel roofing is in fair condition as the wall steel cladding is in fair condition with only some minor staining.

**Figure 21: Generator Building Wall Cladding Stains**

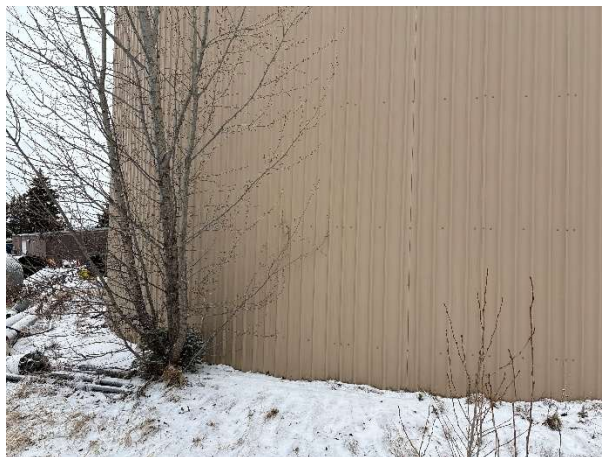
The Water Storage Reservoir roof was not assessed due to lack of accessibility at the time of inspection. The wall cladding is in good to fair condition with minimal staining and no signs of denting, penetrations, or corrosion. The roof should be assessed further to confirm the condition is fair or better; however, with the condition of the wall cladding being good to fair, the roofing condition is not likely a concern.

**Figure 22: Water Storage Reservoir Wall Cladding**

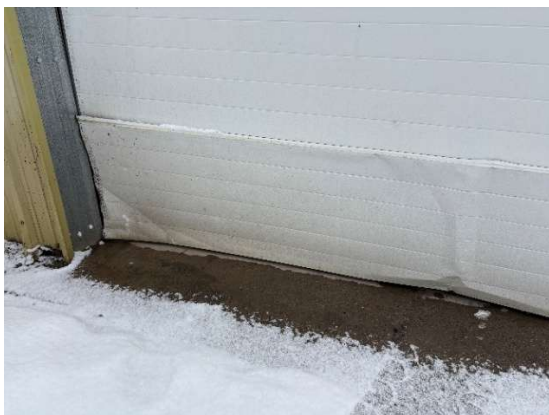
There are no windows on the Main WTP Building. The garage door on the north side of the building is in poor condition with substantial warping and bends on the bottom panel which appears to have been caused by equipment impact. The weather stripping around the garage door is also in poor condition with warping resulting in voids. The man door on the north side of the building is in fair to poor condition with some paint flaking and staining. Substantial staining is apparent on the interior face of the door and weatherstripping is worn out as daylight can be seen from within. The east man door frame is in fair to poor condition with visible paint flaking. Weather stripping and the door itself appear to be in good condition.

**Figure 23: Main WTP Building North Garage Door  
Damage**

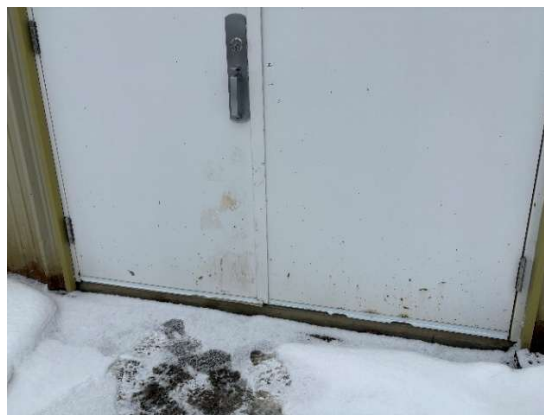
**Figure 24: Main WTP Building North Man Door  
Deterioration**

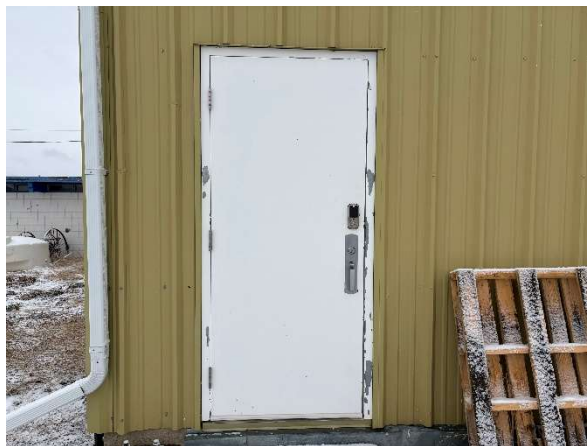
**Figure 25: Main WTP Building East Door Frame Paint Flaking**

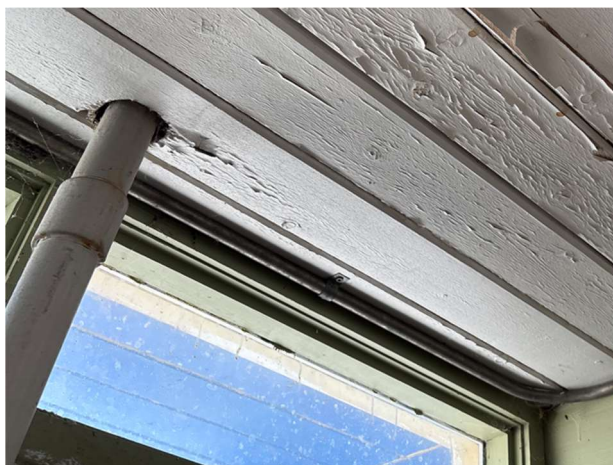
The windows on the Bulk Water Distribution Building appear to be at the end of their service life. The deteriorated frames, caulking, and single pane glass result in reduced thermal performance. The man door on the west side of the building is in fair condition along with the door frame and weather stripping.

**Figure 26: Bulk Water Distribution Building Window Deterioration**

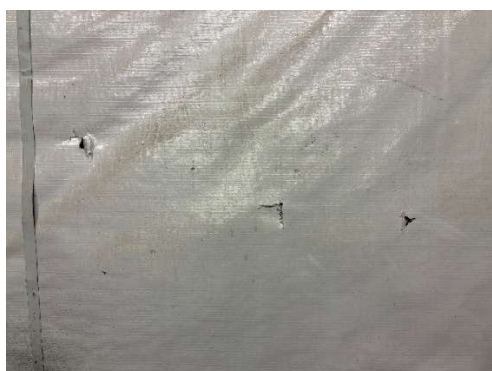
In the Main WTP Building, insulation on the roof and walls is concealed by a vapour barrier which is exposed on the interior face of the building exterior surfaces. The plastic liner is in fair to poor condition with some penetrations and joint separations. Although the fiberglass insulation itself is concealed in most cases, there has likely been some environmental exposure resulting in insulation degradation to a state of fair to poor condition. Interior face pre-finishing corrugated steel wall and roof cladding/decking is in good condition in the WTP room. Drywall and paint finishing on the interior walls are in fair to poor condition with some scuffs and drywall tape exposure. The linoleum flooring in the office area is covered in dirt but appears to be in fair condition. The slab epoxy finish in the WTP portion of the building and in the public works shop washroom is deteriorated. No slab epoxy finish appears to have been applied in the public works garage portion of the building.

**Figure 28: Main WTP Building Plastic Liner Penetrations**

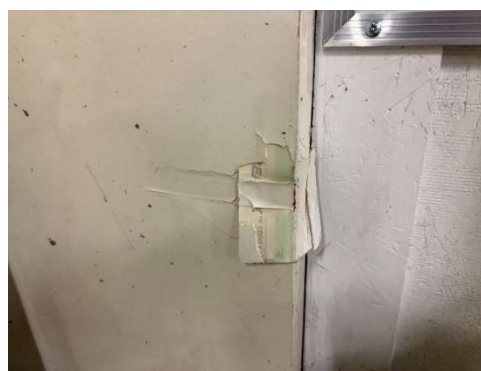
**Figure 29: Main WTP Building Drywall Damage**

Drywall scuffs and damage should be patched and refinished to match the existing throughout the Main WTP Building.

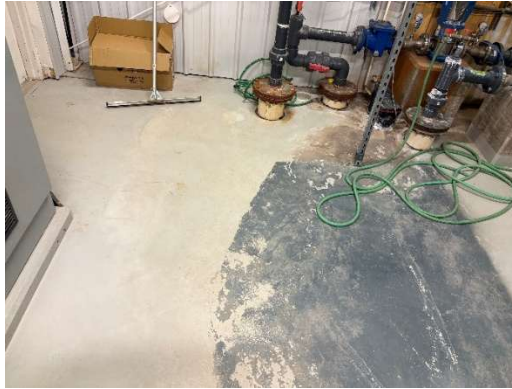
**Figure 30: Main WTP Building Slab Epoxy Finish Deterioration**

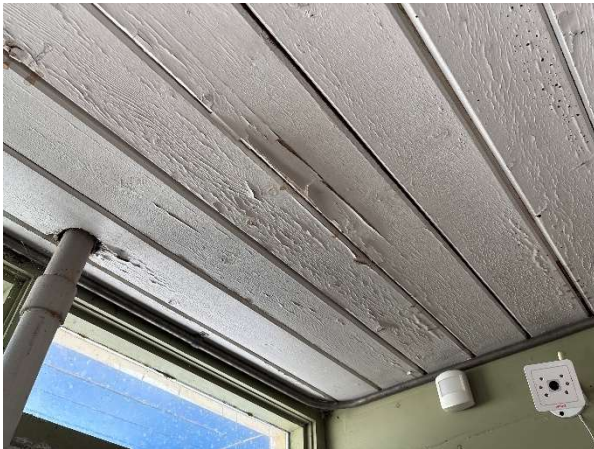
In the Bulk Water Distribution Building, the ceiling plank paint is flaking substantially throughout the building. Paint on the CMU block wall interior faces is worn out and stained in many instances. The exposed interior face of the foundation wall is also painted and flaking is apparent. Overall, the interior building paint finishes are in poor condition. The caulking between CMU blocks is worn out and cracking in the expansion joint caulking is common. The slab epoxy finish is deteriorated across the entire surface resulting in reduced traction and debris spread across the floor.

**Figure 31: Bulk Water Distribution Building Ceiling  
Paint Flaking**

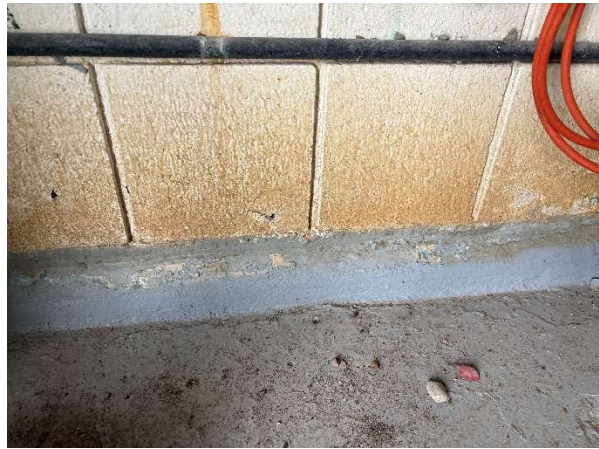
**Figure 32: Bulk Water Distribution Building Worn Out  
Wall Paint**

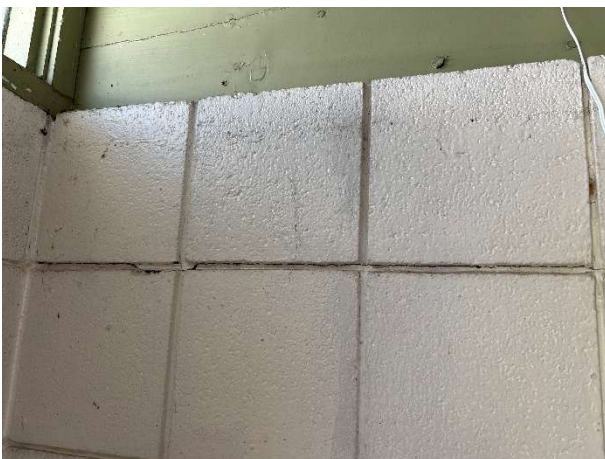
**Figure 33: Bulk Water Distribution Building Worn Out Wall Caulking**

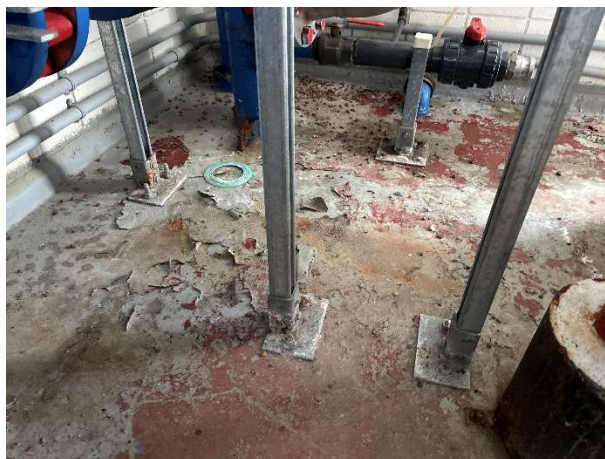
**Figure 34: Bulk Water Distribution Building Slab Epoxy Finish Deterioration**

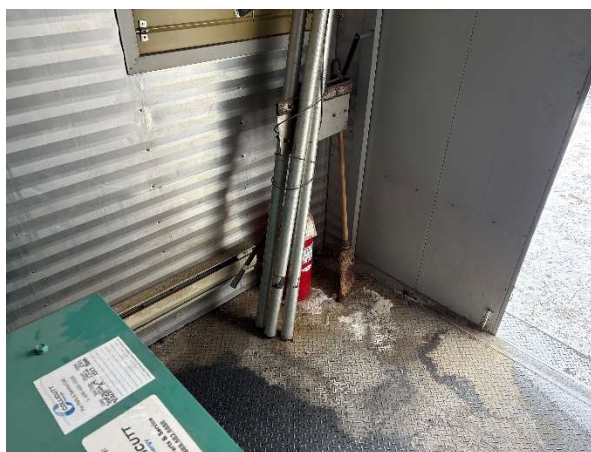
The interior face of the Generator Building is covered with a steel liner which is in good condition. The checkered steel plate floor is in fair condition with some staining.

**Figure 36: Generator Building Floor Staining**

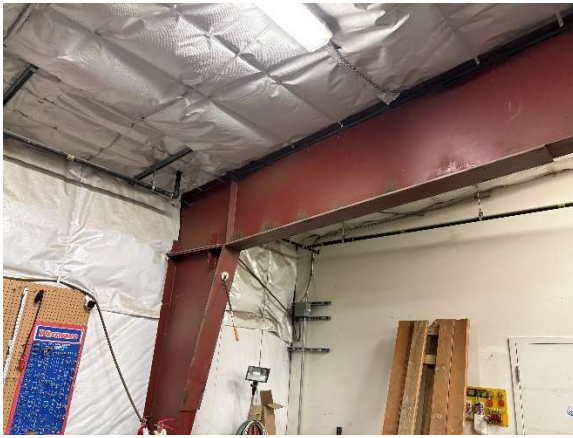
In the Main WTP Building, some of the pre-engineered steel building structure can be assessed from the building interior. Roof beams and columns appear to be in fair condition. Some welds across steel roof

framing members appear to be burnt through. These weld defects may result in reduced capacity. Steel connections including baseplates and bolts appear to be in good condition. The slab throughout the Main WTP Building is in fair condition with some cracking and popouts visible across the interior surface. If this slab is indeed a structural slab suspended on beams and piles, the capacity of the slab may be reduced enough to warrant concern. The office roof in the Main WTP Building is currently being utilized as a storage space. Storage loading can be greater than roof loading and it is unclear if the office roof structure was designed for storage loading. From the Main WTP Building exterior, a potential shear crack in the concrete slab/beam can be seen at the suspected underpinning location at the southeast corner of the building.

Figure 37: Main WTP Building Steel Beam/Column  
Weld Burns

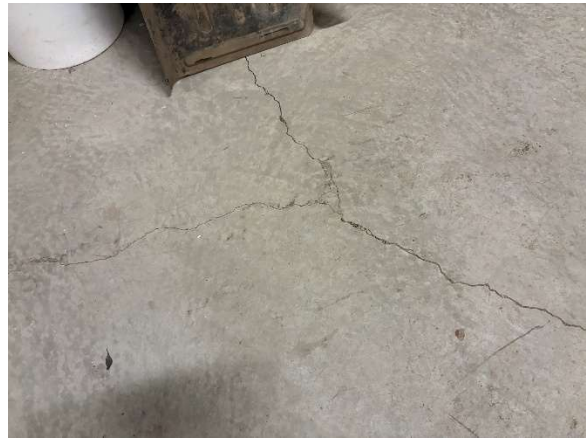
Figure 38: Main WTP Building Slab Cracking

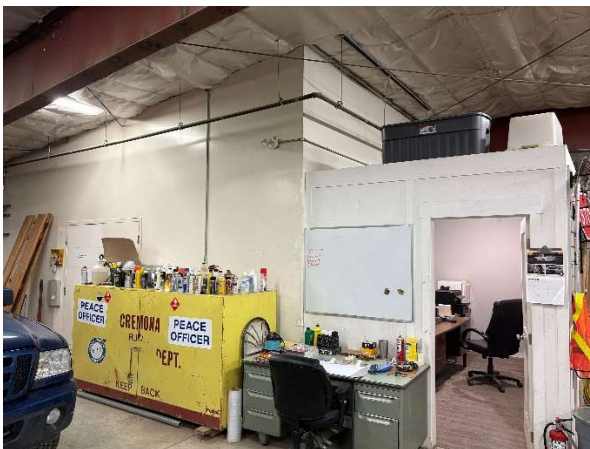
Figure 39: Main WTP Building Office Roof Storage

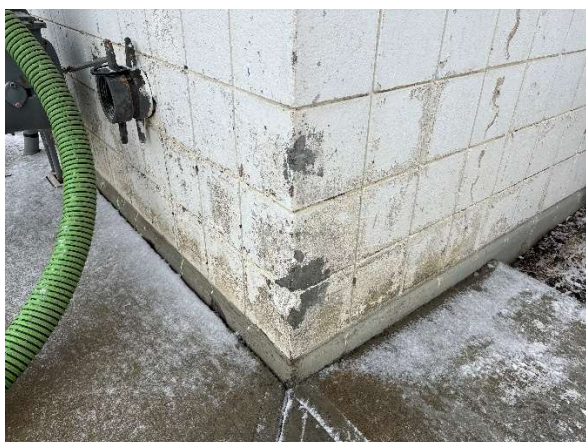
In the Bulk Water Distribution Building, some of the CMU wall blocks are damaged from what appears to be abrasions. As a result, chunks of the CMU blocks as large as 13mm (1/2") deep and 38mm (1.5") across

have been broken off from the building. It is unlikely that these abrasions have resulted in the building walls being over structural capacity at this time. The top 200mm (8") of foundation wall is exposed around the building. The foundation wall appears to be in fair condition. There was some minor cracking identified that is not suspected to impede the foundation walls structural integrity.

**Figure 41: Bulk Water Distribution Building CMU Wall  
Block Abrasions**

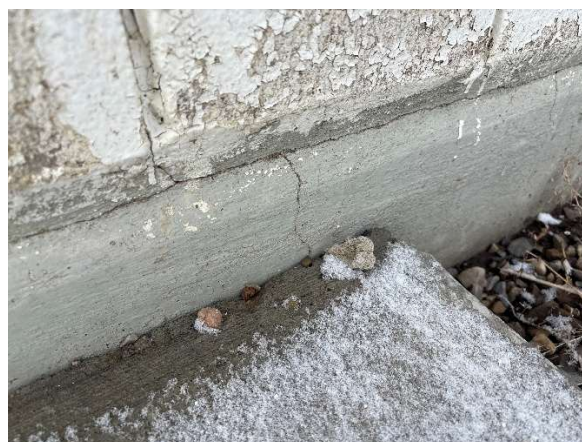
**Figure 42: Bulk Water Distribution Building  
Foundation Cracking**

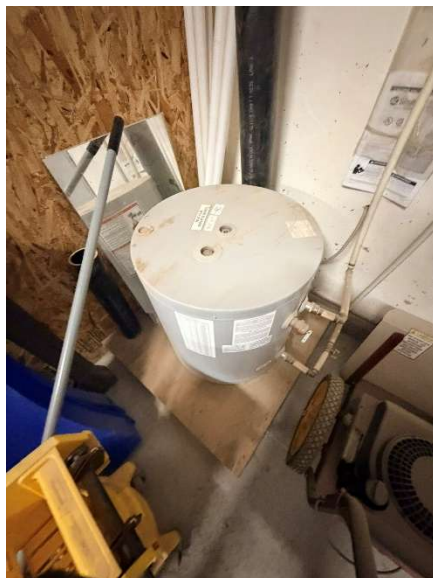
A small tank-type A.O. Smith electric water heater is installed at floor level in the Public Works Shop. The make and model could not be confirmed due to the absence of drawings and a nameplate. This unit only serves the plumbing fixtures in the Public Works Shop washroom. It is installed on a wooden plywood base, providing separation from the floor. The water heater appears to be in good condition, with no visible corrosion, deformation, or signs of active leakage at the piping or base. As the building was constructed in 2012, it is assumed the unit was also installed that same year. Tank-type water heaters typically have a service life of 10-15 years. Therefore, the unit is estimated to have approximately 1 year of remaining service life.

**Figure 43: Public Works Shop Water Heater**

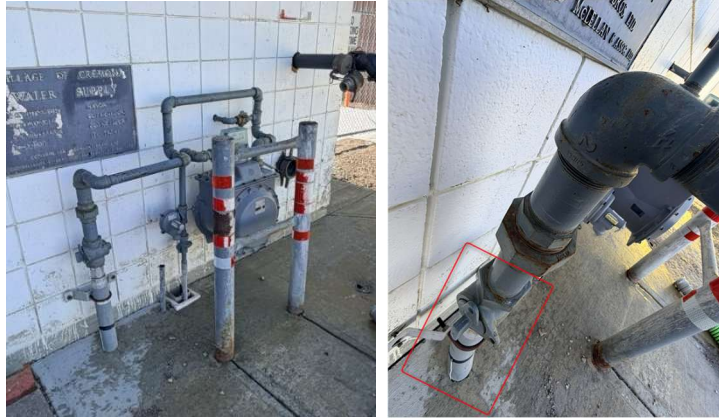
The exterior gas piping is protected by steel bollards with reflectors. The vertical pipe dropping to below grade appears slightly curved, as shown in Figure 5. However, no visible damage or cracking was observed. This condition should be monitored over time for any movement or change. Additionally, corrosion and weathering are present on the gas piping, valves, and bollards, which is consistent with exterior exposure.

**Figure 46: Bulk Water Distribution Building Gas Service**

| Section 2 | Item | Rating | Risk Factor | Photo | Bldg. Section | Description/Condition | Estim. Cost |
|---|---|---|---|---|---|---|---|
| 2.1.4 | Gas Service | 3 | Urgent | | Exterior | <p>The main natural gas service at the bulk water distribution building rises from below grade and appears to be in good condition, with steel bollard protection in place. Surface corrosion and weathering on exterior gas piping and valves should be cleaned and repainted to extend service life and maintain corrosion resistance.</p> <p>At the public works shop &amp; WTP Building, the 50 mm (2") natural gas supply for the building rises from below grade and enters through the wall to serve the gas-fired unit heaters and water heater. While currently in good condition, localized corrosion should be addressed through cleaning and repainting where required.</p> | \$ 10,000.00 |

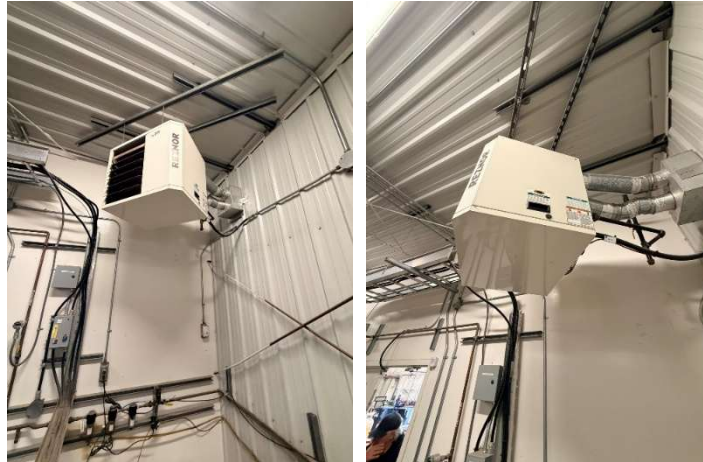
The WTP is primarily heated by a gas-fired unit heater (UH-3). The unit heater is a Reznor unit, but the model and capacity of the unit cannot be determined. From the construction drawings, the unit was installed in 2012. The thermostat is wall-mounted below the heater and is readily accessible for operation. The unit appears to be properly vented and in good condition. Unit heaters typically have a service life of approximately 30 years. Therefore, the unit has an estimated remaining service life of approximately 16 years.

**Figure 51: WTP Unit Heater (UH-3)**

| Section 2 | Item | Rating | Risk Factor | Photo | Bldg. Section | Description/Condition | Estim. Cost |
|---|---|---|---|---|---|---|---|
| 2.2.2 | Gas-fired Unit Heaters (UH-3) | 4 | Low | | Water Treatment Plant | Heating in the WTP is provided by a gas-fired unit heater (UH-3). The equipment is a Reznor unit. However, the make and model could not be confirmed. The unit appears to be in good condition and was installed in 2012. The unit has an estimated remaining service life of approximately 16 years, based on a typical service life of 30 years. Replacement is recommended within this timeframe. | \$ 10,000.00 |

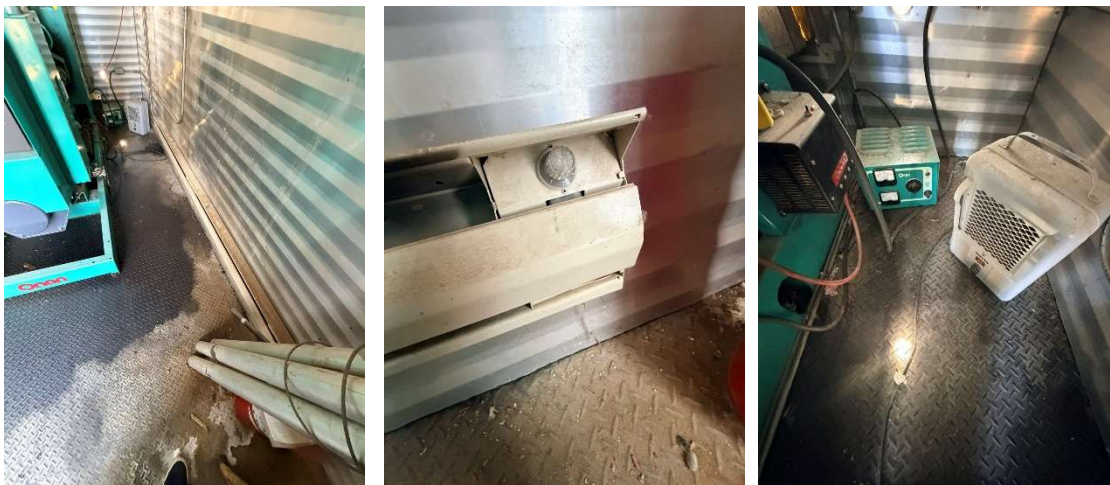
Heating in the Generator Building is provided by an electric baseboard heater and a portable electric space heater, both with integral controls. The make, model, and age of the units could not be determined, as no nameplates were present. Based on their physical condition, the units appear aged, with heavy dust accumulation observed. However, no visible signs of melted plastic, burn marks, or overheating were noted. Despite this, dust accumulation can contribute to reduced reliability and an increased fire risk if not properly addressed.

**Figure 52: Baseboard Heater & Portable Heater**

| Section 2 | Item | Rating | Risk Factor | Photo | Bldg. Section | Description/Condition | Estim. Cost |
|---|---|---|---|---|---|---|---|
| 2.2.3 | Electric Baseboard Heater and Portable Electric Space Heater | 2 | Urgent | | Generator Building | Heating in the generator building is provided by an electric baseboard heater and a portable electric space heater, both with integral controls. Based on their physical condition, the units appear aged, with heavy dust accumulation observed. It is recommended that all heating equipment be incorporated into a routine maintenance program, including periodic cleaning and inspection to reduce fire risk. | \$ - |

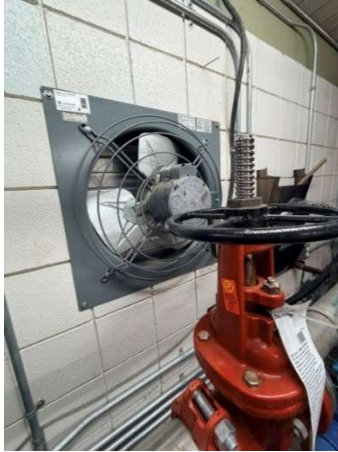
Exhaust for the Bulk Water Distribution Building (pump station) is provided by a wall-mounted exhaust fan. The fan is a Canarm S18-F2 (SD180421), rated at 3,200 cfm (1,510 L/s) with a 457.2 mm (18") blade diameter, manufactured in May 2003. The fan housing and grille appear intact, with no visible cracks, distortion, or missing fasteners. The blades and guard are clean and undamaged, with no signs of impact or deformation. Overall, the fan is in good condition. Given a typical service life of approximately 30 years for exhaust fans, the unit has an estimated remaining service life of approximately 7 years.

Figure 59: Wall Exhaust Fan

| Section 2 | Item | Rating | Risk Factor | Photo | Bldg. Section | Description/Condition | Estim. Cost |
|---|---|---|---|---|---|---|---|
| 2.2.7 | Exhaust Fan | 4 | Medium | | Bulk Water Distribution Building (Pump Station) | Exhaust for the bulk water distribution building (pump station) is provided by a Canarm wall-mounted exhaust fan. The fan housing and grille appear intact, with no visible cracks, distortion, or missing fasteners. The blades and guard are clean and undamaged, with no signs of impact or deformation. Based on a typical service life of approximately 30 years for exhaust fans, the unit has an estimated remaining service life of about 7 years. It is recommended to plan for replacement within the next 8 years to ensure continued reliable operation. | \$ 8,000.00 |

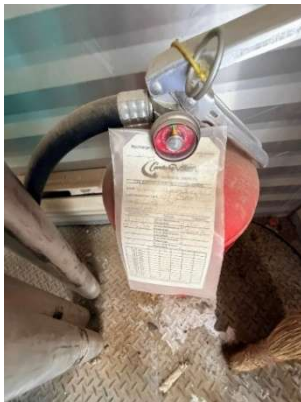
The Public Works Shop & WTP Building, Generator Building, and Bulk Water Distribution Building (pump station) are not equipped with fire sprinkler systems. Fire protection is primarily provided by handheld fire extinguishers located throughout the buildings, specifically at the entrances/exits. Based on the service tags, the fire extinguishers were recently inspected in March 2026 and are in acceptable condition, except for the fire extinguisher in the Generator Building. According to its service tag, the last recorded inspection date for this unit is 2010, as shown in [Figure 60](#). This extinguisher is therefore considered non-compliant and unreliable for emergency use.

Figure 60: Generator Building Fire Extinguisher

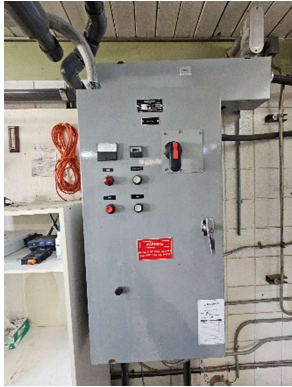
The existing fire pump controller is manufactured by Westinghouse, while the transformer disconnect is manufactured by Federal pacific. Both manufacturers are no longer in operation. While both equipment appear to be in good condition with no visible signs of damage, their age suggests that their internal components such as contactors and relays may be approaching the end of their service life.

Figure 67: Fire Pump Controller
