# **VILLAGE OF CREMONA**

## **SCADA BUILDING - BUILDING CONDITION ASSESSMENT**

**Date: May 8, 2026**

**Project #: 2490-019-01**

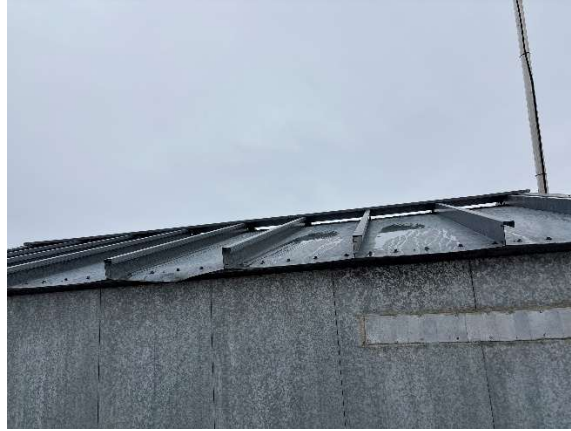
The roof configuration appears to be a gable roof system sloping towards the north and south sides of the building. The roofing material is a standing seam metal roofing assembly complete with a metal fascia on the east and west gable ends of the building. The interior face of the roof is complete with a pre-finished steel liner.

**Figure 1: Standing Seam Steel Roofing**

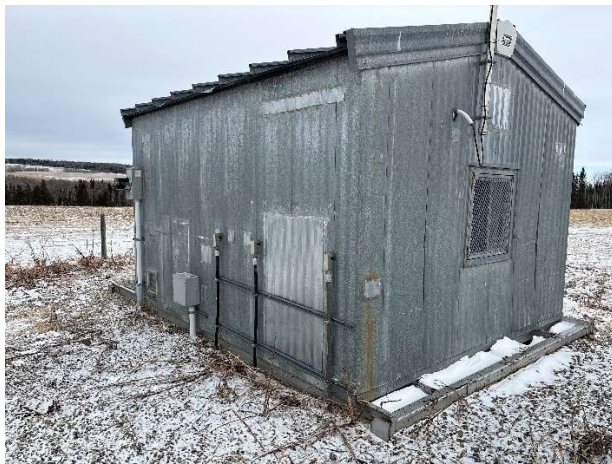
The walls of the building are suspected to be light gauged steel complete with exterior steel cladding and interior pre-finished steel lining. Various exterior steel patching panels have been installed at what are suspected to be past mechanical or electrical openings.

**Figure 2: Steel Wall Cladding**

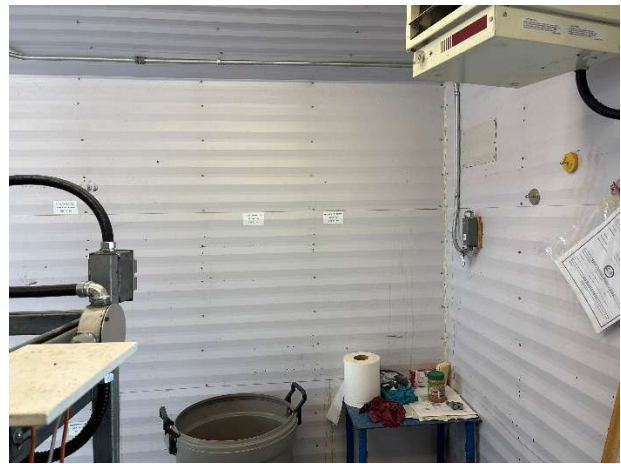
**Figure 3: Interior Steel Wall Lining**

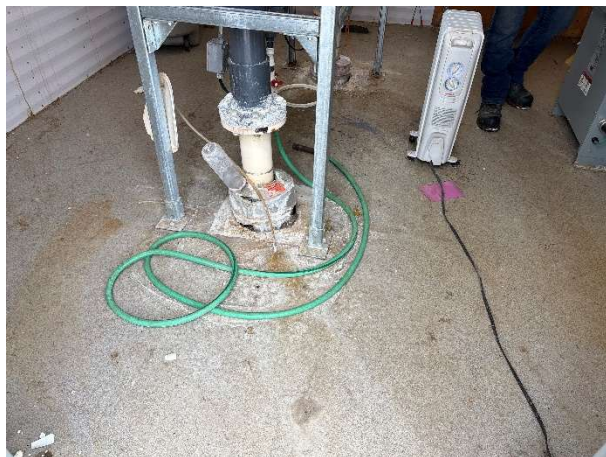
The floor structure is unknown as there was no exposed structural floor components as they were covered by a resilient flooring material. It is suspected that the floor structure is light gauged steel framing sitting atop the steel skid frame. There is steel grating on the west exterior side of the building that extends outwards about 610mm (2') and spans the width of the building.

**Figure 4: Interior Flooring**

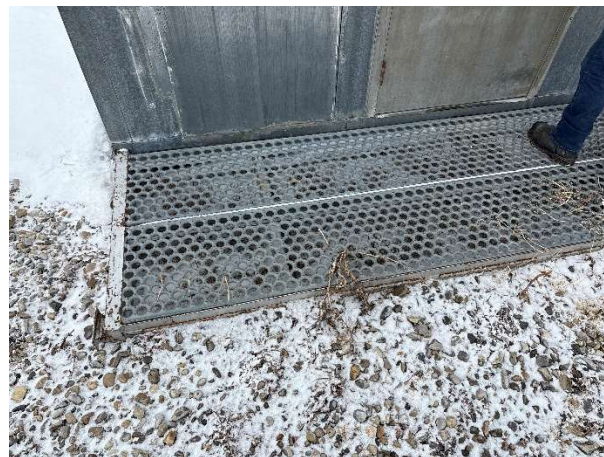
**Figure 5: Exterior Grating**

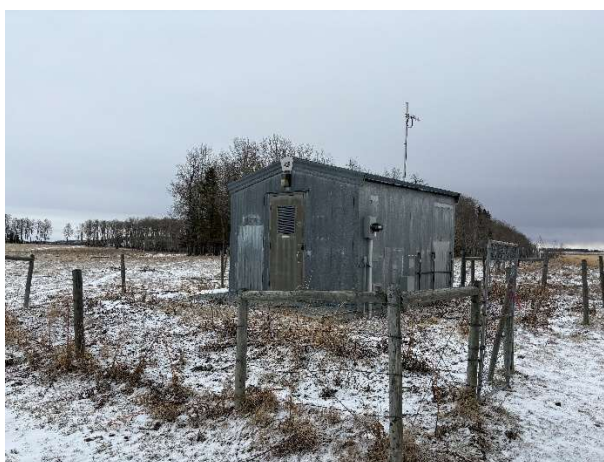
The site around the building is grass with a mild slope away from the building foundation. There were no erosion channels observed on the ground surface at the time of the assessment; however, drainage performance was not evaluated beyond visual observation.

**Figure 6: Building Site**

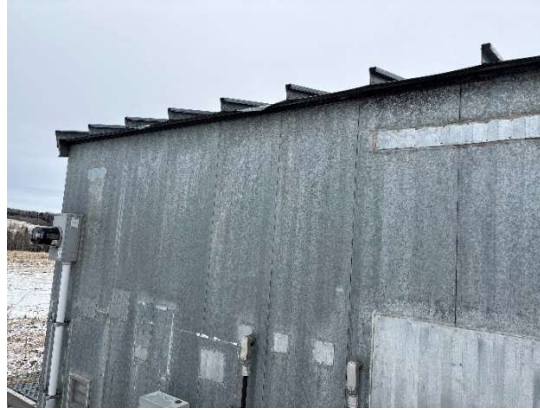
There are no eavestroughs, downspouts, or downspout extensions on the building. With the roof slope directing water to the north and south sides of the building. With no roof drainage system, roof surface runoff is directed to the north and south base of the building.

**Figure 7: Missing Roof Drainage System**

Eavestroughs should be installed on the north and south sides of the building. Downspouts and downspout extensions should be installed as to direct water from the eavestroughs away from the building foundation. Eavestrough, downspout, and downspout extensions should be pre-finished metal to match roofing and/or cladding colour for exterior application as recommended by an accredited architect in the Province of Alberta.

| Section 1 | Item | Rating | Risk Factor | Photo | Comments/Concerns | Estim. Cost |
|---|---|---|---|---|---|---|
| 1.1.1 | Eavestroughs, Downspouts, and Downspout Extensions | 1 | Medium | | Eavestroughs should be installed on the north and south sides of the building. Downspouts and downspout extensions should be installed as to direct water from the eavestroughs away from the building foundation. Eavestrough, downspout, and downspout extensions should be pre-finished metal to match roofing and/or cladding colour for exterior application as recommended by an accredited architect in the Province of Alberta. | \$ 5,000.00 |

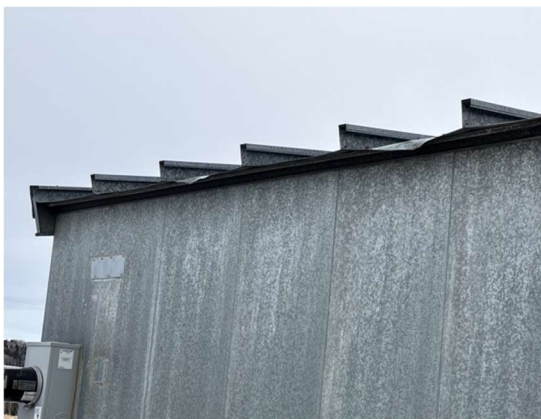
The standing seam steel roof decking is in fair to poor condition as the steel is warped at the overhanging edges in many instances. This can cause tears in the sheet metal and eventually result in roof leaking if left unattended to. The steel sheet metal wall panels are in poor condition with rust staining, patched sections, dents, and staining across the wall surfaces. Fascias on the east and west ends of the building are in similar condition as the steel wall panels. The exterior grating appears to be in fair condition with little denting and no signs of corrosion or rusting.

**Figure 8: Roof Decking Warping**

Standing seam steel roofing should be replaced with a pre-finished product for exterior application as recommended by an accredited architect in the Province of Alberta to reduce the potential for roof leakage.

| Section 1 | Item | Rating | Risk Factor | Photo | Comments/Concerns | Estim. Cost |
|---|---|---|---|---|---|---|
| 1.2.1 | Roof Decking | 3 | High | | Standing seam steel roofing should be replaced with a pre-finished product for exterior application as recommended by an accredited architect in the Province of Alberta to prevent roof leaking. | \$ 10,000.00 |

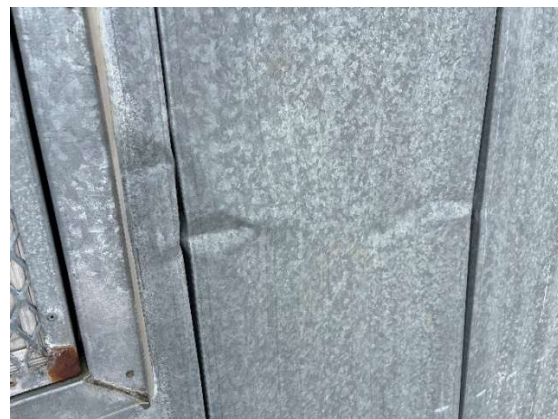
**Figure 9: Wall Cladding Dents**

Exterior steel sheet wall panels should be replaced with a pre-finished steel sheet or corrugated steel wall panel product for exterior applications as recommended by an accredited architect in the Province of Alberta.

| Section 1 | Item | Rating | Risk Factor | Photo | Comments/Concerns | Estim. Cost |
|---|---|---|---|---|---|---|
| 1.2.2 | Wall Cladding | 2 | High | | Exterior steel sheet wall panels should be replaced with a pre-finished steel sheet or corrugated steel wall panel product for exterior applications as recommended by an accredited architect in the Province of Alberta. | \$ 18,000.00 |

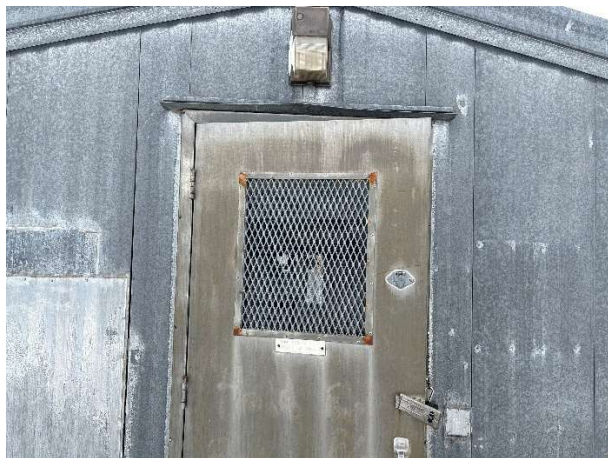
The man door, door frame, and weather stripping are worn out as corrosion is visible on the door/hinges and staining is evident across most of the surfaces. The window glass and frame are also worn out as

**Figure 10: Worn Out Man Door**

The man door, door frame, and weather stripping should be replaced with an industrial grade exterior door that is finished with an exterior grade paint and primer as recommended by an accredited architect in the Province of Alberta to improve overall building enclosure performance and reduce the potential for moisture intrusion.

| Section 1 | Item | Rating | Risk Factor | Photo | Comments/Concerns | Estim. Cost |
|---|---|---|---|---|---|---|
| 1.2.3 | Man Door, Door Frame, and Weather Stripping | 2 | Medium | | The man door, door frame, and weather stripping should be replaced with an industrial grade exterior door that is finished with an exterior grade paint and primer as recommended by an accredited architect in the Province of Alberta to improve building energy performance and prevent moisture intrusion. | \$ 3,000.00 |

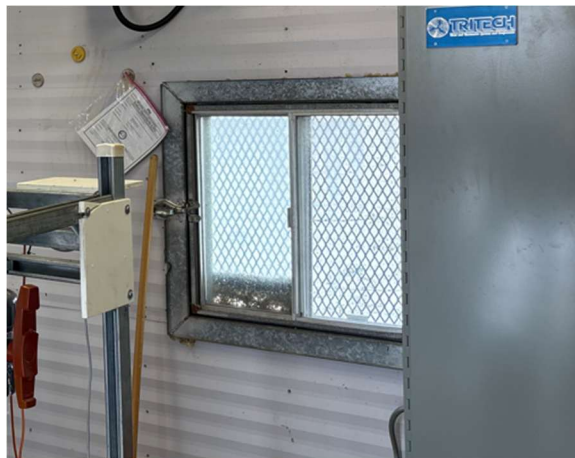
corrosion was visible on the window frame and frost covered the bottom portion of the window glass interior. These items being worn out result in poor thermal performance and moisture intrusion that can accelerate subsequent building deterioration.

**Figure 11: Worn Out Window**

The window glass and frame should be replaced with an industrial product as recommended by an accredited architect in the Province of Alberta to improve building energy performance and prevent moisture intrusion.

| Section 1 | Item | Rating | Risk Factor | Photo | Comments/Concerns | Estim. Cost |
|---|---|---|---|---|---|---|
| 1.2.4 | Window and Window Frame | 3 | Medium | | The window glass and frame should be replaced with an industrial product as recommended by an accredited architect in the Province of Alberta to improve building energy performance and prevent moisture intrusion. | \$ 5,000.00 |

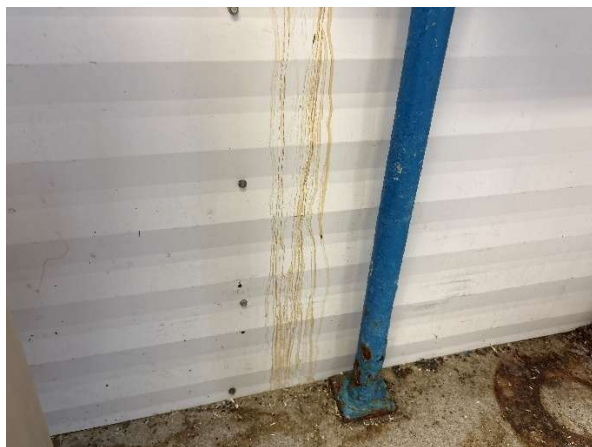
Damage to the interior building envelope was observed throughout the building, though the overall interior building envelope condition was fair. The metal wall panels show surface discoloration and staining due to corrosion-related runoff. The joint caulking appears to be cracked in many instances. These items could be related is rust runoff is leaking through the cracked joint caulking and staining the interior metal lining. The linoleum flooring is in poor condition with substantial staining and instances of ripping.

**Figure 12: Interior Steel Liner Staining**

The rust runoff stained interior steel wall lining should be cleaned properly as outlined by the product fabricator to reduce the potential for further deterioration.

| Section 1 | Item | Rating | Risk Factor | Photo | Comments/Concerns | Estim. Cost |
|---|---|---|---|---|---|---|
| 1.2.5 | Interior Steel Liner | 2 | Low | | The rust runoff stained interior steel wall lining should be cleaned properly as outlined by the product fabricator as to prevent further deterioration. | \$ 250.00 |

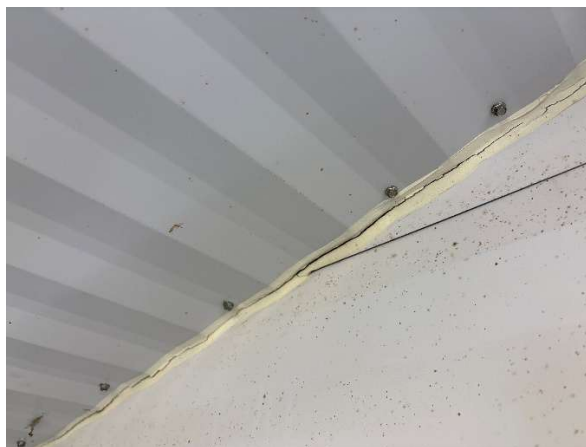
**Figure 13: Cracked Joint Caulking**

The joint caulking around the interior liner should be reapplied to the interior face building envelope liner joints with an exterior grade caulking product with tensile adhesive and cohesive capacity.

| Section 1 | Item | Rating | Risk Factor | Photo | Comments/Concerns | Estim. Cost |
|---|---|---|---|---|---|---|
| 1.2.6 | Interior Steel Liner Joint Caulking | 2 | Medium | | The joint caulking around the interior liner should be reapplied to the interior face building envelope liner joints with an exterior grade caulking product with tensile adhesive and cohesive capacity. | \$ 500.00 |

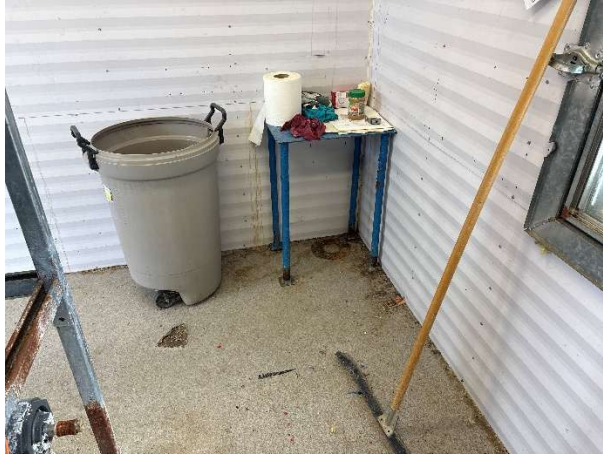
**Figure 14: Stained and Ripped Linoleum Flooring**

The linoleum flooring should be replaced with an industrial grade product as to prevent further ripping and provide simple surface cleaning.

| Section 1 | Item | Rating | Risk Factor | Photo | Comments/Concerns | Estim. Cost |
|---|---|---|---|---|---|---|
| 1.2.7 | Linoleum Flooring | 2 | Medium | | The linoleum flooring should be replaced with an industrial grade product as to prevent further ripping and provide simple surface cleaning. | \$ 2,500.00 |

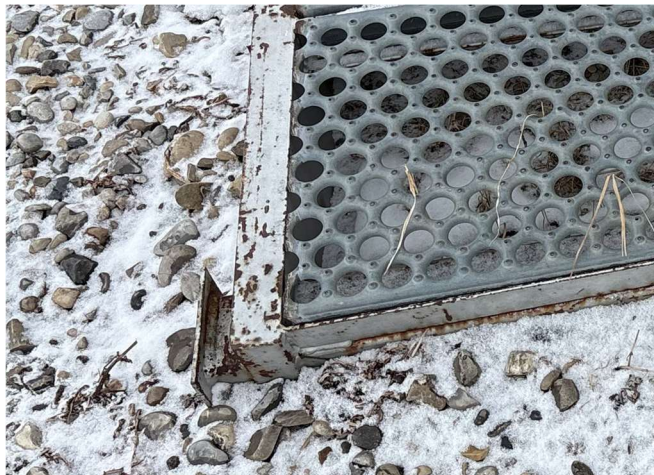
Based on visual observations of accessible components, the apparent structural condition of the superstructure appears to be fair. No analytical verification of structural capacity or integrity was performed. There was some corrosion identified on the steel skid frame beneath the building. Although corrosion was observed on the steel skid frame, it does not appear, based on visual observation, to be advanced at this time.

**Figure 15: Steel Skid Corrosion**

The corrosion of the steel skid should be monitored. A rust prohibiting paint should be applied to the steel skid in the meantime as to minimize the potential for continued corrosion. If condition worsens, a structural assessment should be completed which may result in member replacement.

| Section 1 | Item | Rating | Risk Factor | Photo | Comments/Concerns | Estim. Cost |
|---|---|---|---|---|---|---|
| 1.3.1 | Corroding Steel Skid | 3 | High | | The corrosion of the steel skid should be monitored. A rust prohibiting paint should be applied to the steel skid in the meantime as to minimize the potential for continued corrosion. If condition worsens, a structural assessment should be completed which may result in member replacement. | \$ 5,000.00 |

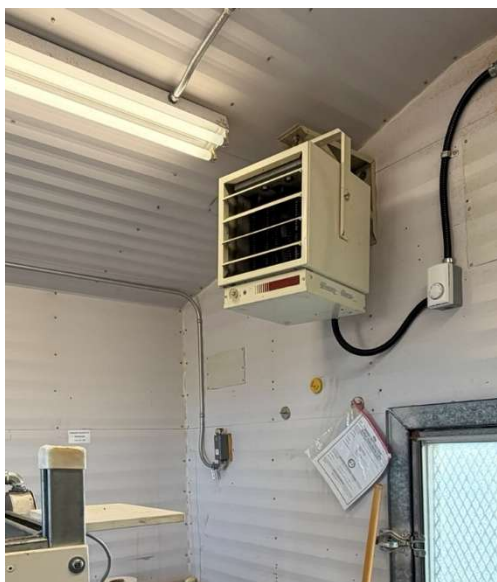
The SCADA building is heated by an electric unit heater and an electric oil-filled radiator heater. The electric unit heater is a Dimplex EUH05B31T rated at 5 kW. The heater is wall-mounted, installed close to the ceiling, and positioned above the window. The unit's thermostat is mounted on the wall in close

proximity to the heater. Based on the unit's nameplate, the unit was manufactured or installed in approximately 2000. The heater appears to be securely mounted, with no visible signs of burning, overheating, or damage. Minor corrosion is present, which is consistent with the unit's age. The electric oil-filled radiator heater is a Honeywell unit that is floor-mounted (bolted in place) and installed adjacent to the water piping riser system. The unit appears to have a plastic housing. The exact model and age cannot be determined due to the absence of a nameplate. However, it is assumed to have been installed at the same time as the unit heater, which was in 2001. The radiator heater appears to have typical surface wear, including scratches, dirt, and dust accumulation. Though there is a chipped plastic component at the bottom of the unit, the control knobs are intact, and there are no signs of oil leakage. Overall, the unit heater and the radiator heater appear to be in good working condition. Unit heaters and oil-filled radiator heaters typically have an expected service life of approximately 30 years. Given that the units were installed in 2001, they have an estimated remaining service life of approximately 5 years, provided they are properly maintained.

Figure 16: Wall-mounted Electric Unit Heater

The electric unit heater and oil-filled radiator heater are generally in good condition, with minor corrosion and slight damage to the exterior housing. Given their age and estimated remaining service life of approximately 5 years, it is recommended that replacement should be planned within the next 5 years to ensure continued reliability.

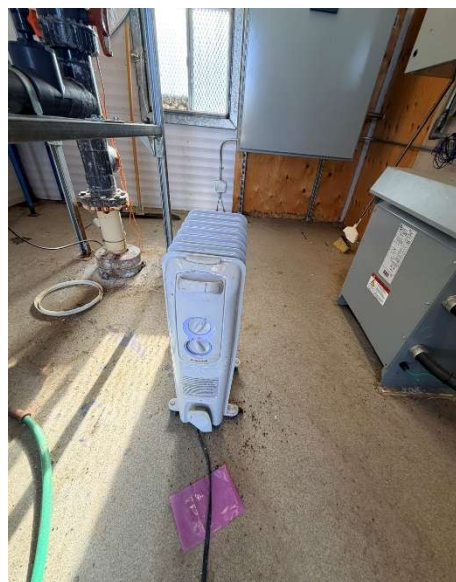
Figure 17: Floor-mounted Electric Oil-filled Radiator  
Heater

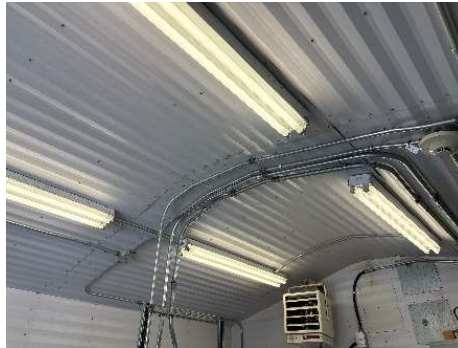
The existing lighting system consists of surface mounted T8 fluorescent lighting and is manually controlled using a switch located near the entrance. Overall illumination appears to be adequate for the space, however the lamps exhibit inconsistent colour temperature and lumen depreciation due to age. It is

important to note that starting January 1, 2026 the import and manufacture of Linear Fluorescent Lights are prohibited in Canada under the Products Containing Mercury Regulations.

**Figure 18: Existing Light Fixture**

It is recommended that existing fluorescent lighting be retrofitted with LED technology or full fixture replacement, depending on project scope and budget. In addition, it is recommended to install an occupancy sensor to allow for lights to automatically turn off when no motion is detected. This would improve energy efficiency and provide more consistent lighting performance.

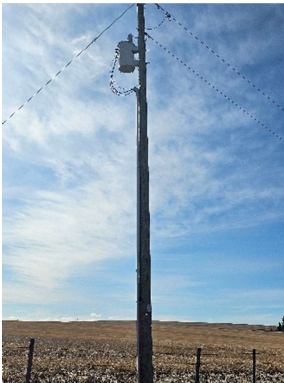
**Figure 19: Fortis Utility Transformer**

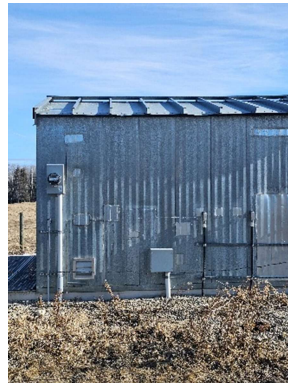
**Figure 20: Fortis Utility Meter**

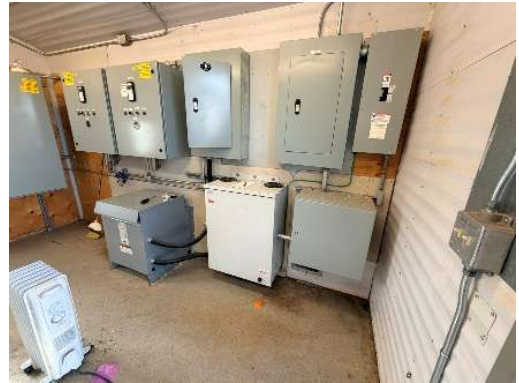
The building is fed from a 120/240V, 1Ph, Fortis Utility Transformer installed in a utility pole, with the utility meter mounted outside the building exterior. The transformer fed a 120/240V, 1Ph, panel. A phase converter and step-up transformer were installed to support the 600V, 3Ph motor loads. Based on available record drawings, the electrical equipment appears to be installed in 2012. Based on the observed condition, the electrical equipment is generally in good operational condition. There are no visible signs of damage or rusting. Minor housekeeping issues were observed, such as dust accumulation and debris on equipment surfaces.

**Figure 21: Existing Electrical Equipment**

From condition perspective, the electrical system appears functional and compliant with typical installation practices. The only recommendation is to address the housekeeping issues, which include the removal of dust and debris accumulation above the equipment. It is also recommended to perform a routine maintenance review by a qualified electrician to confirm proper operation of the phase converter and motor controls to ensure continued reliability of the system.

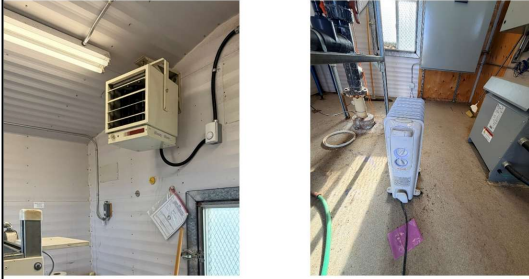
| Section 2 | Item | Rating | Risk Factor | Photo | Bldg. Section | Description/Condition | Estim. Cost |
|---|---|---|---|---|---|---|---|
| 2.1.1 | Electric Unit Heater and Oil-filled Radiator Heater | 4 | Medium | | Wall and Floor of Building | The electric unit heater and oil-filled radiator heater are generally in good condition, with minor corrosion and slight damage to the exterior housing. Given their age and estimated remaining service life of approximately 5 years, it is recommended that replacement should be planned within the next 5 years to ensure continued reliability. | \$ 6,000.00 |

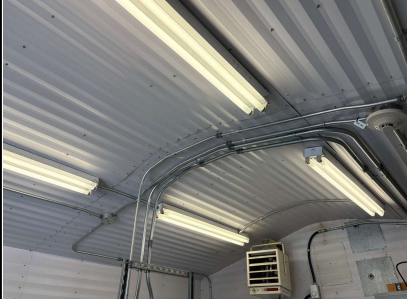
| Section 3 | Item | Rating | Risk Factor | Photo | Bldg. Section | Description/Condition | Estim. Cost |
|---|---|---|---|---|---|---|---|
| 3.1.1 | Interior Lighting System | 4 | Low | | | The existing lighting consists of T8 fluorescent lighting and is manually controlled by a switch located in the entrance door. There could be difficulty in getting replacement bulbs in the future as they are being phased out. It is recommended to upgrade to LED and line voltage occupancy sensor. | \$ 5,000.00 |

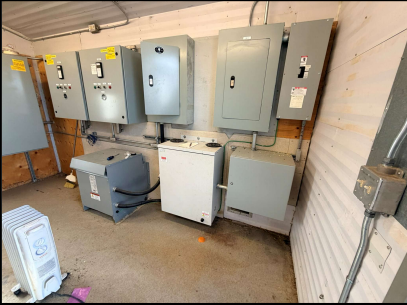
| Section 3 | Item | Rating | Risk Factor | Photo | Bldg. Section | Description/Condition | Estim. Cost |
|---|---|---|---|---|---|---|---|
| 3.2.1 | Electrical equipment consisting of 120/240V panelboards, phase converter, step-up transformer, 347/600V panelboards, and soft starter. | 4 | Low | | | Based on the observed condition, the electrical equipment is generally in good operational condition. There are no visible signs of damage or rusting. Minor housekeeping issues were observed, such as dust accumulation and debris on equipment surfaces. | \$ 35,000.00 |
