# **VILLAGE OF CREMONA**

## **OLD UNITED CHURCH - BUILDING CONDITION ASSESSMENT**

**Date: May 8, 2026**

**Project #: 2490-019-01**

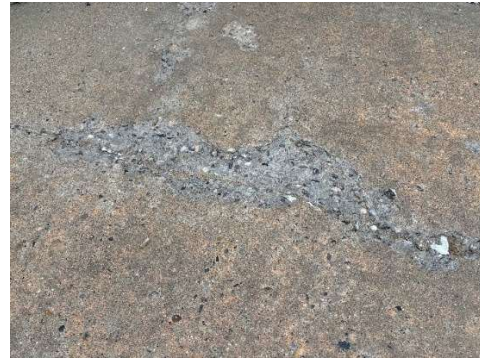
**Figure 7: Concrete Stairs Deterioration**

The site around the four sides of the building is grass. On the north and east sides of the building, there is a gravel road about 3m (9.8') away from the building walls. General grading to the east and south of the building is sloped away from the building foundation. The grading to the north and west of the building is relatively flat. Various concrete walkways are located around the building site. The walkways are generally in fair condition with some minor cracking. The front stair concrete on the south side of the building is in poor condition with surface cracking and popouts along with visible cracking on the side of the concrete

stairs. If left in their current state, ongoing moisture infiltration and freeze-thaw exposure may contribute to continued deterioration of the stair and walkways.

Concrete cracks, popouts, and other deterioration around the site and on the flat and vertical stairway surfaces should be patched and repaired using an exterior grade patching compound. This is intended to reduce the potential for further deterioration associated with moisture intrusion and freeze-thaw exposure.

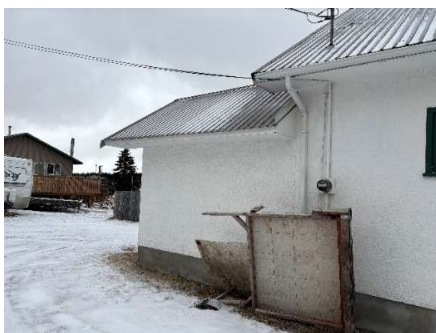
**Figure 8: Missing Eavestrough**

Around the building, eavestroughs are generally in fair condition. Eavestroughs have been installed at all applicable roof edges except for at the east end of the north building wall on the lower-level roof. Without an eavestrough at this location, water runoff from the roof is guided to the building foundation, rather than being direct away from it. The downspout and downspout extension at the southwest corner of the building is missing. The downspout extension at the northwest corner of the building is missing. The downspout extension along the north side of the building is missing. These missing downspouts and downspout extensions negate the role of the eavestrough by still allowing roof runoff to pool against the building foundation.

A pre-finished eavestrough, downspout, and downspout extension should be installed on the north face of the east stairway building portion roof to provide proper drainage away from the building foundation. The eavestrough should match the existing.

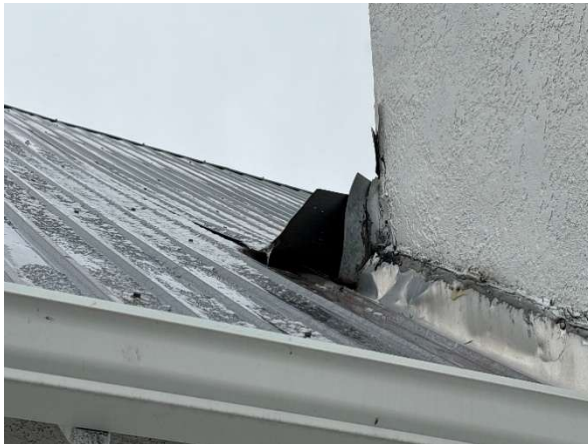
**Figure 10: Roof Decking Deficiency**

The corrugated steel roof cladding is generally in fair to poor condition. In some instances where cladding intersects a protruding wall, decking is bent up the wall face rather than a proper flashing installation

being completed. This condition may create openings in the roofing system, which can allow moisture intrusion and contribute to building envelope deterioration. These openings can also serve as pest intrusion points which can cause further building damage and pose safety concerns to occupants. Overall, the roof cladding surface appears to be worn and likely nearing the end of its service life. The wall stucco is generally in fair to poor condition with minor staining. There were several cracks identified in the stucco which appear to be related to foundation movement due to settlement or serviceability cracking around openings. A larger crack is located adjacent to the east stairway building portion. It is probable that this section has a foundation which acts independently to the main building structure and the stucco cracking is potentially a result of differential settlement between the foundations. The parging around the foundation wall is in poor condition with substantial deterioration at building corners. These instances of building envelope deterioration throughout the exterior wall finishes can result in moisture intrusion which accelerates deterioration due to envelope saturation and freeze-thaw crack expansion. There are no soffit panels on the roof overhangs which exposes the wood framing beneath. The wood framing appears to be painted for exterior exposure.

The building's corrugated steel roof cladding should be replaced with a pre-finished corrugated steel roof cladding and appropriate flashing. The pre-finished corrugated steel roofing product and flashing should be selected by an accredited architect in the Province of Alberta.

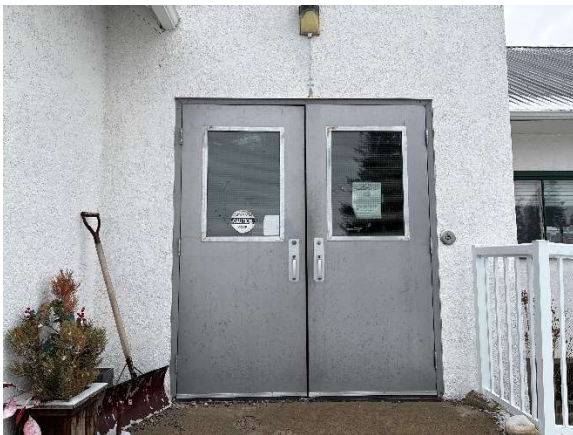
**Figure 14: Worn Out Exterior Door**

The exterior doors, door frames, and weather stripping are in fair to poor condition. There is some paint deterioration on the door surfaces and on the door frames. The handle on the southeast main door has some rust staining. Weather stripping throughout the exterior doors is worn out as some daylight can be seen around the door perimeters from the building interior. The windows and window frames appear to be worn out and due for replacement from both the interior and exterior of the building. The glass is faded and the frame paint is fading. A south face basement window is installed without proper flashing, exposing the spray foam insulation beneath. This can result in moisture penetrating the building envelope and causing moisture related damage like rotting and insulation saturation. These window and door concerns result in poor building energy performance.

Exterior doors, door frames, and weather stripping should be replaced around the building as the current elements have reached the end of their service life. The main floor window glass and frames around the building should also be replaced. Exterior envelope finishes should be applied up to the south basement window frame to conceal the spray foam insulation and complete the building envelope seal. With the observed poor condition of the aforementioned building components, the energy performance of the building is likely poor and the opportunity for moisture intrusion at these locations is high.

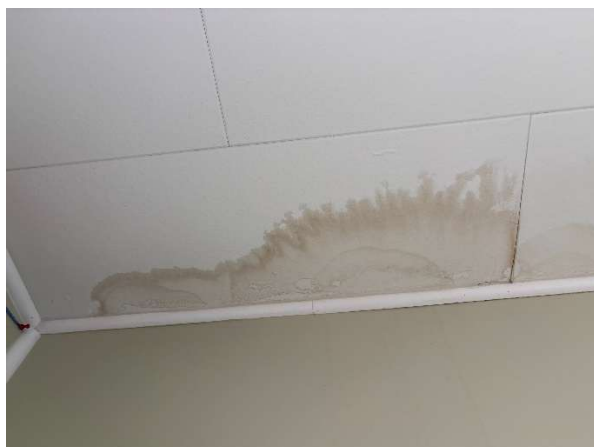
**Figure 17: Stained Ceiling Tile**

The ceiling finishes on the interior of the building are generally in poor condition. Numerous suspended drywall ceiling tiles on the main and basement level are moisture stained, warped, or have paint flaking. The basement level moisture stained is suspected to be related to a mechanical issue which has since been addressed. The main floor ceiling moisture staining is likely the result of roof cladding condition being poor as there are openings in decking material and fastener gasket deterioration allowing for moisture infiltration. The drywall ceiling in the main chapel room is in fair condition with some drywall tape warping but no visible cracking or staining. Interior molding finishes are in fair to poor condition. On the main floor, some baseboards are damaged or missing entirely and, in the basement, some ceiling trip boards are disconnected from the walls.

Stained and/or damaged ceiling tiles and drywall should be replaced and finished as required to match existing. Examination should be completed where moisture staining is apparent to determine the cause of staining and if the issue has been resolved.

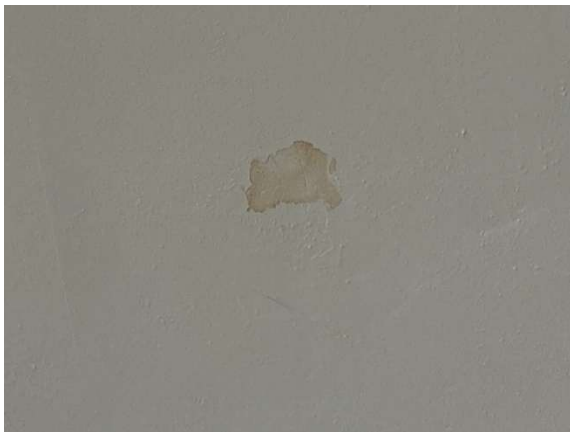
**Figure 20: Damaged Wall Drywall**

The wall drywall has numerous scuffs and abrasions throughout the building. The wall paneling is faded and moisture stained in many instances. Overall, the interior wall finishes are in fair to poor condition. The carpet on the main floor of the building is generally in fair condition with minor staining and no visible signs of fraying. The newly installed linoleum faux hardwood flooring in various main floor rooms is in good condition. The laminate tile flooring in the main floor kitchen is in poor condition with substantial staining and some penetrations. In the basement, carpet is installed directly on top of the slab-on-grade in many rooms. This is poor practice as any moisture that leaks through slab cracks will be trapped in the carpet, rather than handled by a sub flooring material. As a result, the basement carpets are in poor condition with staining and fraying across large portions of the surface. These issues can result in building odour and mold.

Damaged drywall should be patched and repaired then finished to match existing throughout the building. Wood wall panelling should be replaced throughout the building as the finish has faded substantially and staining is prevalent across the surfaces, minimizing aesthetics and envelope performance.

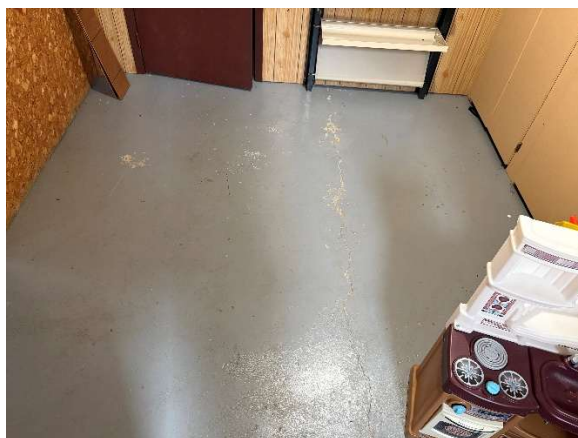
**Figure 24: Slab Epoxy Finish Deterioration**

The epoxy paint finish in the basement is in fair to poor condition with some abrasions across the surface and peeling as a result of slab cracking. This slab epoxy paint finish deterioration can lead to reduced traction and concrete surface exposure.

Slab epoxy paint finish throughout the exposed basement floor slab should be stripped and replaced to match existing as deterioration worsens.

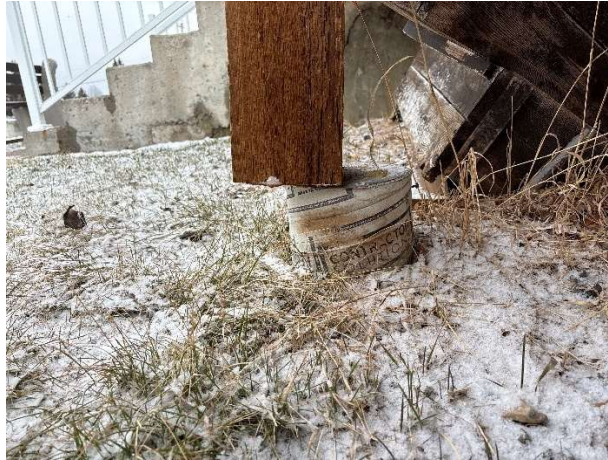
**Figure 25: Ramp Post Eccentricity**

The ramp access structure at the south side of the building is wood framed with solid sawn lumber posts supported on concrete piles. Many posts are offset from the piles by as much as half of the post width or 70mm (2.8") limiting the bearing area to less than half of the probable design intention and creating eccentricity in the system. There also does not appear to be a fastening system between the posts and piles. These two issues combined raise concern regarding the structural performance and long-term durability of the ramp system, based on visual observation only.

South ramp access posts should be evaluated and re-aligned, as required, with supplemental wood framing and appropriate connections to the existing concrete piles to address observed eccentricity and improve load transfer . The required structural changes should be designed by an accredited engineer in the Province of Alberta.

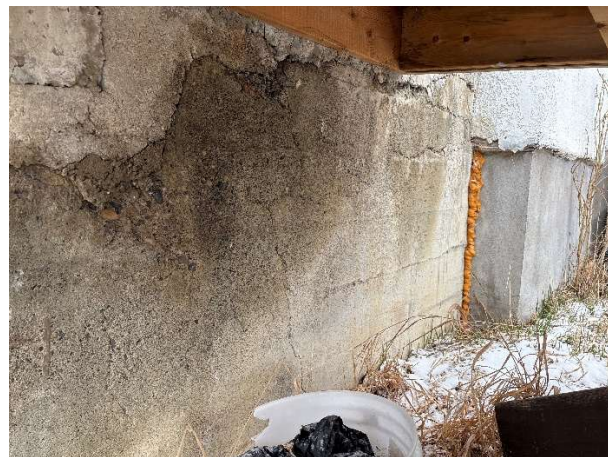
**Figure 26: Front Stairway Concrete Deterioration**

At the south main entrance reinforced concrete stairway, there appears to have been a stair addition which lengthened the stairs poured over top of the existing stairs. The new overpoured stairs are in fair condition aside from the surface deterioration mentioned as a site concern previously. The original supporting stair structure has some vertical cracking and popouts visible from the side of the structure. These cracks and popouts do not appear, based on visual observation, to presently compromise the stairway's load-carrying capacity; however, if left in their current state, these conditions may contribute to accelerated concrete deterioration due to moisture intrusion and freeze-thaw exposure.

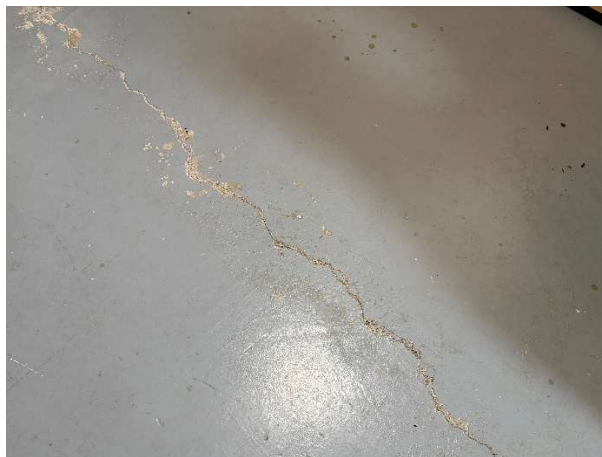
**Figure 27: Basement Slab Cracking**

The basement slab on grade is in fair to poor condition with settlement related cracking identified around the slab surface. The cracks are less than 5mm (0.19") in thickness and do not appear to extend through the entire slab cross section. With these observed conditions, the slab cracking does not appear, based on visual observation, to indicate a structural performance concern at this time.

The basement slab cracking should be patched and repaired with an exterior grade patching compound and finished to match the existing slab epoxy paint finish. This is intended to reduce the potential for pest and moisture intrusion through the slab and to mitigate slab crack-related tripping hazards to occupants.

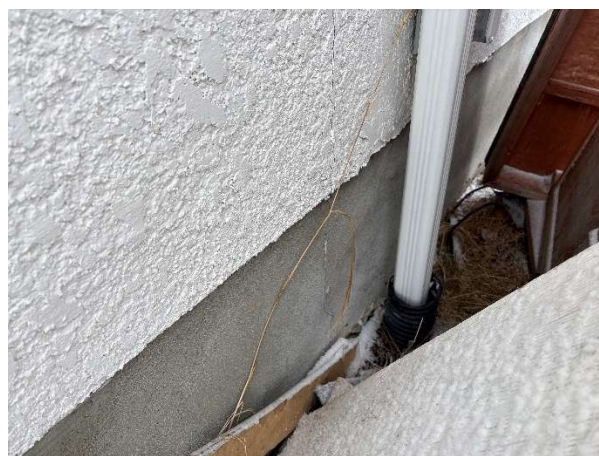
**Figure 28: Parging Crack at East Stairway Building Portion**

At the east stairway building portion, the vertical cracking observed in the stucco appears to continue through the parging. It is possible that the foundation wall may be cracked at this location; however, the condition of the foundation wall could not be directly verified due to concealment. The observed cracking may be associated with differential movement between the main building and the stairway structure, based on visual interpretation only.

The eavestrough missing on this portion of the building may potentially be causing over settlement due to soil instability. It is not likely this becomes a structural integrity concern if the missing eavestrough is addressed.

The parging cracking and deterioration around the exterior of the building foundation should be patched and repaired using an exterior parging compound. The parging patching should be finished to match the existing. This will aid in the protection of the interior building envelope from moisture intrusion and restore aesthetics.

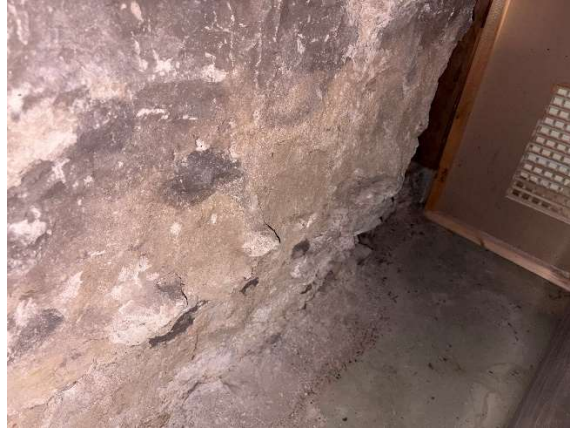
**Figure 29: Foundation Wall Crumbling**

The basement foundation wall was constructed using dated concrete mix requirements which utilized large aggregates (as much as 150mm (6") in diameter). As a result, the concrete is crumbling in some instances throughout the basement. Much of the foundation wall is concealed by interior wall finishes; however, in some rooms this crumbling can be observed. This wall appears to be robust enough that some

crumbling will not likely impact structural integrity; however, if deterioration were to continue unchecked, the effective capacity of the foundation wall may be reduced over time

The crumbling sections of foundation wall should be stripped to sound concrete and then patched and repaired using an exterior grade patching compound. This is intended to slow further foundation wall deterioration and reduce the potential for moisture intrusion through the foundation wall.

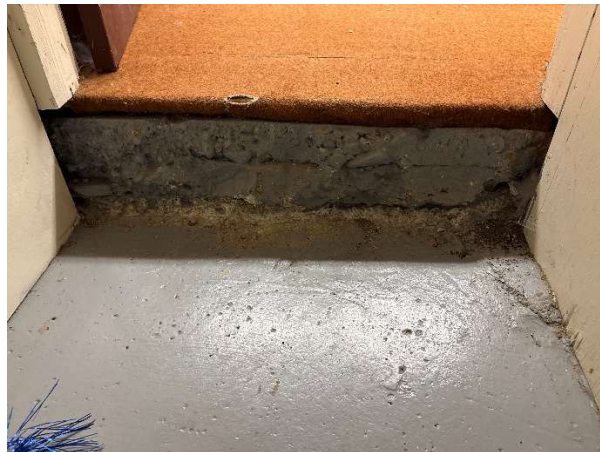
**Figure 30: Basement Step Concrete Deterioration**

In the west room of the basement, concrete deterioration was identified at the stepped-up slab. It is probable that this deterioration is related to improper joint design between the raised slab and the remaining basement slab along with lack of exposed edge protection. It does not appear to be a structural integrity concern as a slab-on-grade in its current condition; however, monitoring is recommended as potential deterioration will continue if left in its current state.

The elevated slab step at the west end of the basement should be patched and repaired using an exterior grade patching compound and finished to match the existing. This is anticipated to slow slab deterioration and reduce occupant tripping hazards at the deteriorated face of the step.

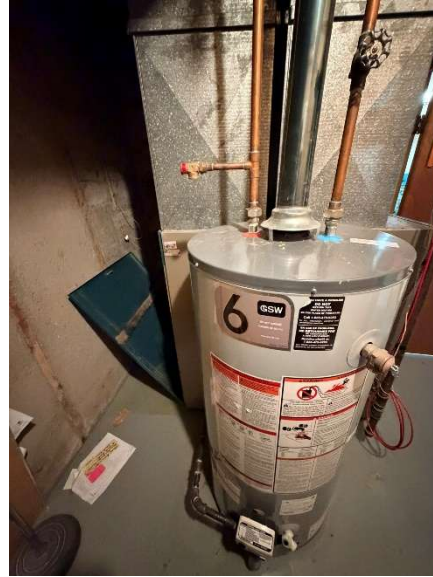
**Figure 32: Domestic Water Heater**

In addition, it was observed that the domestic hot water piping associated with the water heater is not insulated. It is recommended that thermal insulation be installed on exposed hot water piping to improve energy efficiency, reduce heat loss, and enhance system performance.

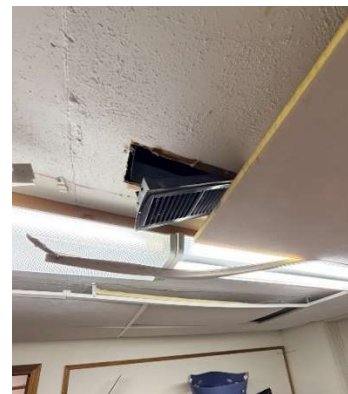
**Figure 45: Detached S/A Grille**

In the basement, the air terminals consist of ceiling-mounted double deflection grilles for supply air, with wall-mounted grilles serving for return air. It was observed that one of the supply air grilles in the basement storage room is detached from the duct opening, leaving the duct opening exposed, as shown in **Figure** . This grille should be reinstalled and properly secured to the ceiling.

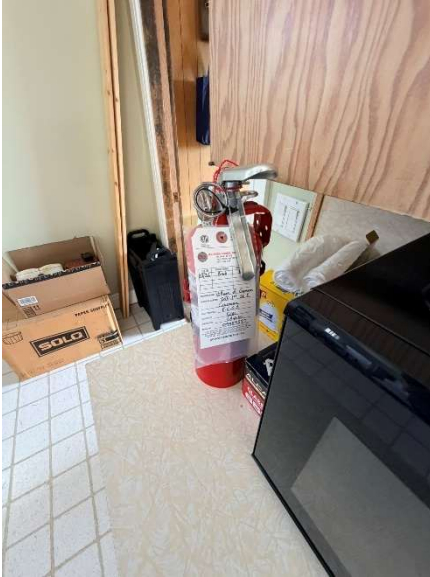
Figure 48: Fire Extinguisher in Kitchenette

It is observed that the fire extinguisher in the kitchenette is placed on the counter near the door, as shown in [Figure](#) . The NFPA 10 specifies that fire extinguishers should be installed on hangers, brackets, or in cabinets. Although the standard does not explicitly prohibit placing a fire extinguisher on a countertop, it

is recommended that the unit be mounted on an appropriate bracket to prevent it from obstructing the area or being accidentally tipped over.
