# **VILLAGE OF CREMONA**

## **PUBLIC WORKS SHOP & WATER TREATMENT PLANT**

### **BUILDING CONDITION ASSESSMENT**

**Date: May 8, 2026**

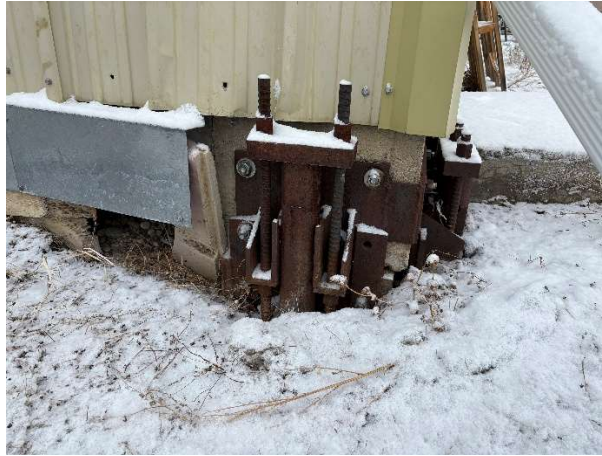
The Main WTP Building foundation is concealed below grade or by perimeter skirting. At the southeast corner of the building, a small section of foundation is exposed which appears to reveal either underpinning at the slab/foundation corner or a pile foundation throughout. With that being the case, it is unclear whether the slab is a structural slab or a slab-on-grade. Comments are made throughout the report considering the slab is structural to provide a more conservative approach to the assessment.

**Figure 11: Main WTP Building Southeast Foundation Corner**

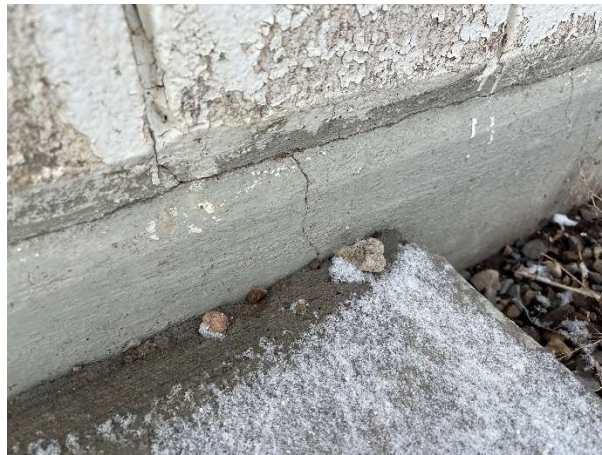
The Bulk Water Distribution Building foundation is concealed below grade. Based on the floor being a slab-on-grade, the superstructure construction, and the age of the building, the foundation is most likely a reinforced concrete shallow foundation featuring strip footings around the perimeter. Part of the reinforced concrete foundation wall is also visible around the building exterior.

**Figure 12: Bulk Water Distribution Building Foundation Wall**

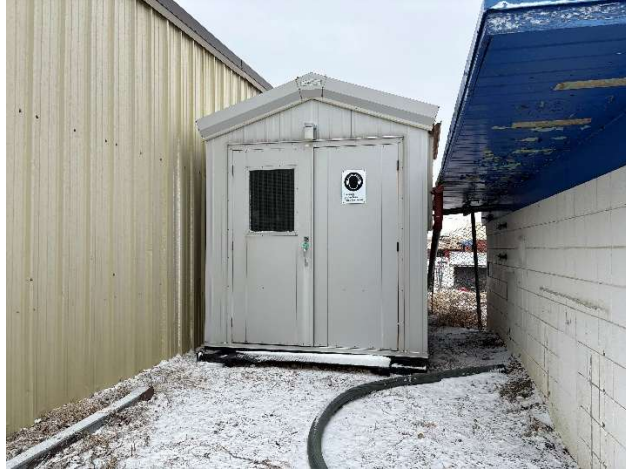
The Generator Building foundation is totally concealed. It is probable that the the prefabricated building is on a pile foundation as the building sits on a skid which is visible from the exterior. Pile foundations are also common for this type of building construction.

**Figure 13: Generator Building Skid**

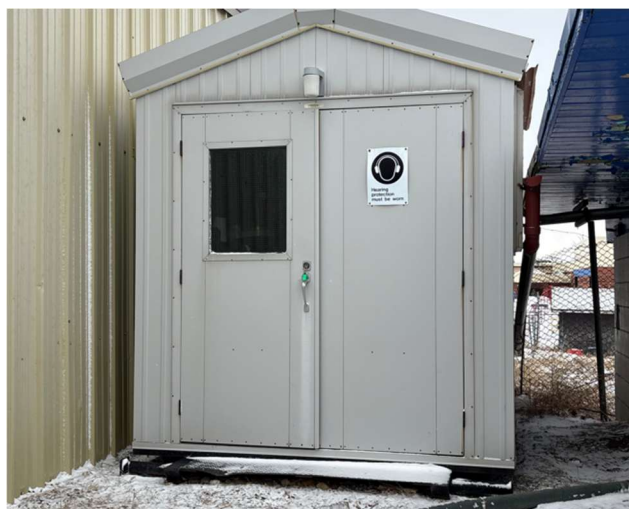
The Generator Building door, door frame, and weather stripping are in good condition and should be performing to their design intent.

**Figure 27: Generator Building Door**

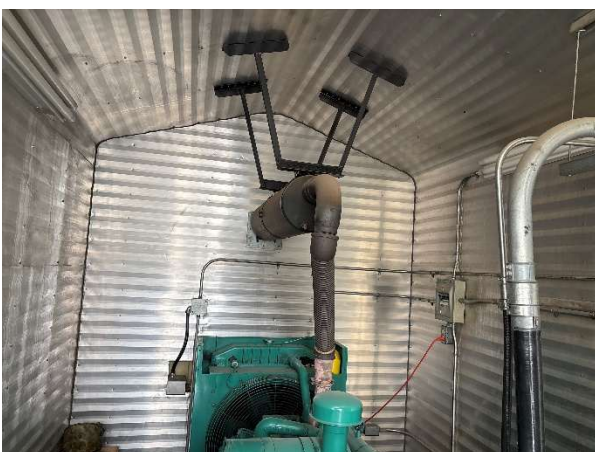
The interior face of the Generator Building is covered with a steel liner which is in good condition. The checkered steel plate floor is in fair condition with some staining.

**Figure 35: Generator Building Interior Steel Liner**

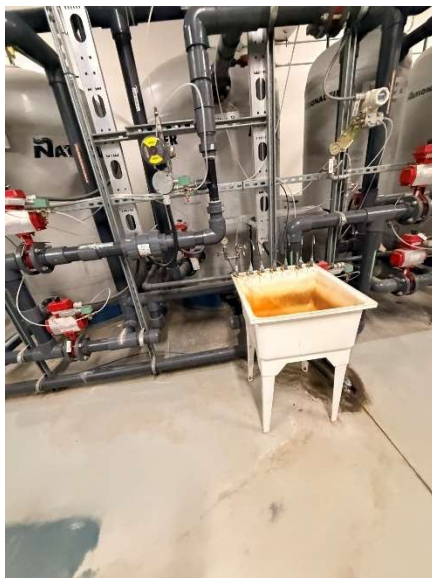
Figure 44: WTP Utility Sink

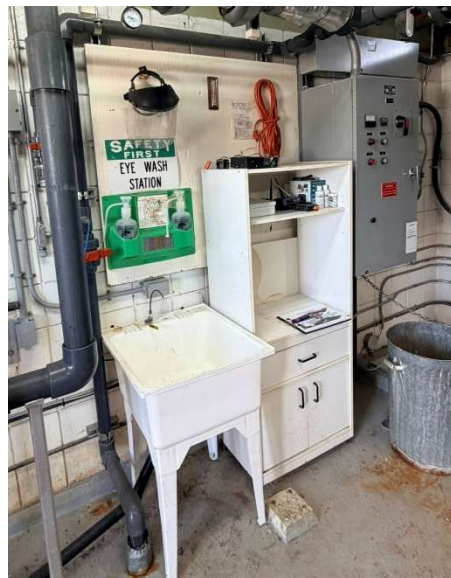
The Bulk Water Distribution Building (pump station) is equipped with a freestanding utility sink, as shown in **Figure 43**, complete with a single-handle pull-down faucet. The sink is made of polypropylene and is

installed below the eyewash station. Its sanitary outlet is routed through piping to an open floor penetration without a floor drain. Although the sink shows surface wear and discoloration, it remains functional.

Figure 45: Bulk Water Distribution Building Utility Sink

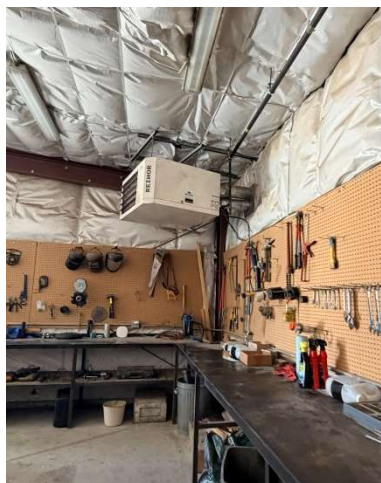
The Public Works Shop is heated by two (2) gas-fired unit heaters (UH-1, UH-2) suspended from the roof structure. The units are Reznor UDAS150-S, with 150,000 Btu/hr (44 kW) input and 124,000 Btu/hr (36

kW) output at 83% efficiency. The thermostats of the heaters are wall-mounted below each heater and are readily accessible for operation. Minor surface marks and discoloration are visible, consistent with normal age and use. However, the units appear to be working as intended. The heaters were installed in March 2012. Unit heaters typically have a service life of approximately 30 years. Therefore, the units have an estimated remaining service life of approximately 16 years.

**Figure 49: Typical Workshop Unit Heater**

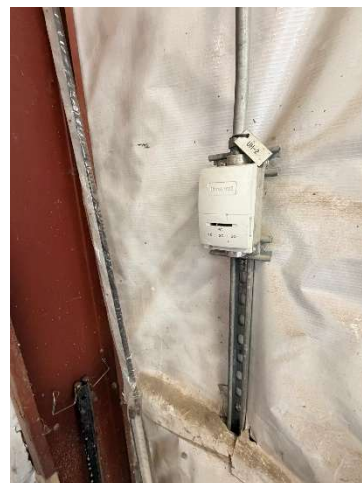
**Figure 50: Typical Unit Heater Thermostat**

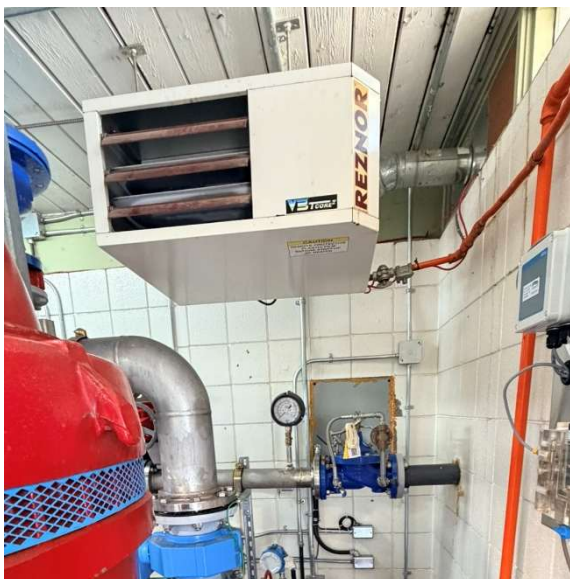
visible signs of burning, overheating, or damage. Overall, the unit is in good working condition. Gas-fired unit heaters typically have an expected service life of approximately 30 years. Therefore, this unit has an estimated remaining service life of approximately 12 years, provided it is properly maintained.

**Figure 53: Unit Heater**

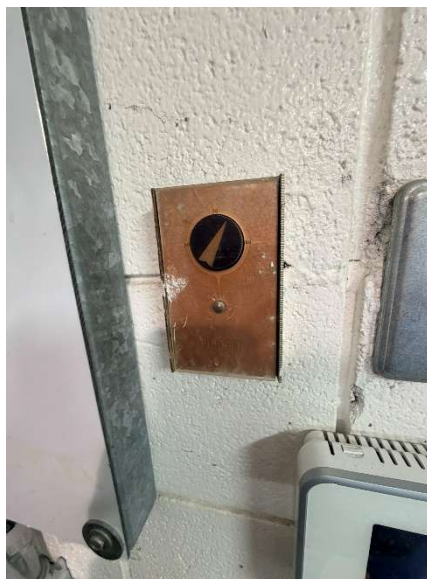
The unit is controlled by a discontinued Pioneer line-voltage thermostat. It is likely that this thermostat was retained from a previous heating system and reused with the current unit. It is assumed to be functioning. However, its performance should be monitored for signs of inefficiency, such as inaccurate temperature readings, unresponsiveness, or failure to properly control the unit heater.

**Figure 54: Unit Heater Thermostat**

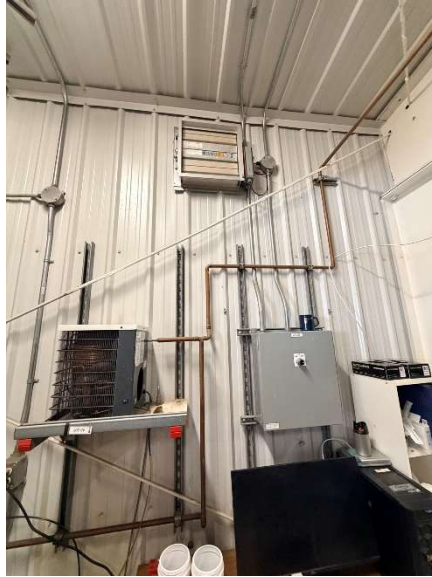
Ventilation for the WTP is provided by a 457x457 mm (18x18") motorized control damper (DM-102) installed on the east wall of the building. The damper is a Tamco unit equipped with a Belimo actuator. The model could not be confirmed, as the nameplate is not visible from ground level. The assembly, including the actuator and electrical connections, appears intact and properly installed, with no visible signs of damage or deterioration. Based on the construction drawings, the unit was part of the 2012 construction. Dampers and actuators typically have a service life of approximately 30 years; therefore, the unit is estimated to have approximately 16 years of remaining service life.

**Figure 55: WTP Motorized Damper (DM-102)**

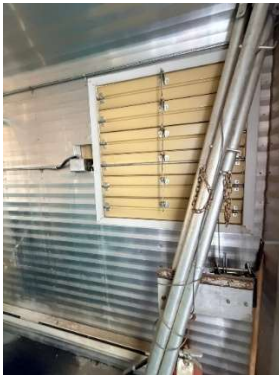
Ventilation in the Generator Building is provided by a manually operated louver. Access to the louver is partially obstructed by stored materials. Overall, the louver and frame are in good condition.

**Figure 56: Manual Louver**

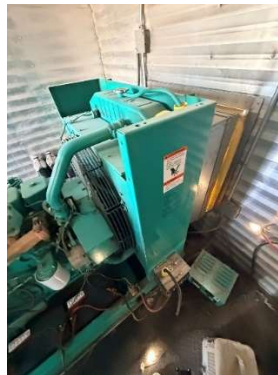
The generator ventilation assembly consists of a wall discharge installed adjacent to the generator set. The venting appears intact and properly aligned, with no visible signs of overheating, leakage, or structural damage. Overall, the system is in good condition.

**Figure 57: Generator Ventilation**

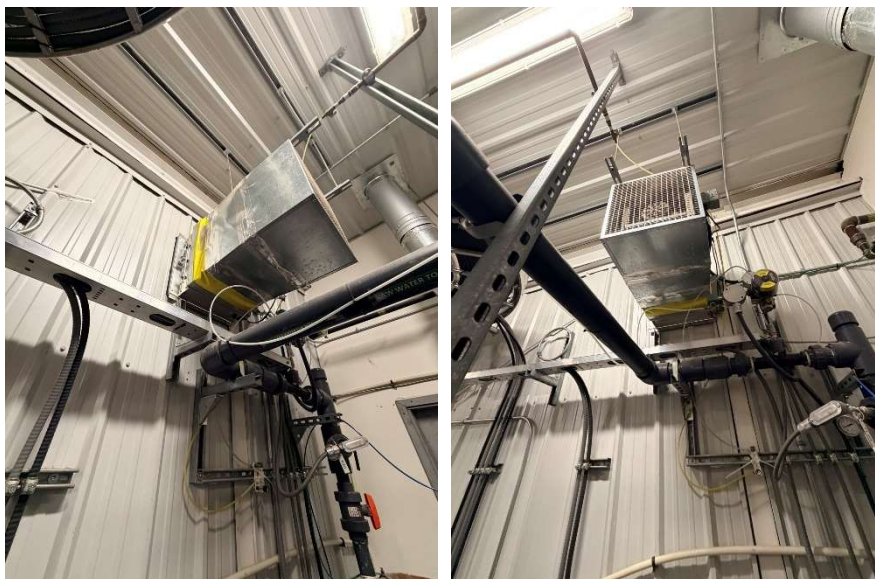
Exhaust for the WTP is provided by a wall-mounted exhaust fan equipped with a 356x356mm (14x14") motorized damper (DM-101). The make and model of the fan and damper could not be confirmed, as the

units' nameplates are not visible. No obvious signs of severe corrosion were observed on the fan housing, and the hangers and supports appear secure. Overall, the units appear to be in good condition. Based on the construction drawings, the fan and the motorized damper were included in the original 2012 construction. Exhaust fans and dampers typically have a service life of approximately 30 years. Therefore, the fan and damper have an estimated remaining service life of approximately 16 years.

**Figure 58: WTP Exhaust Fan**

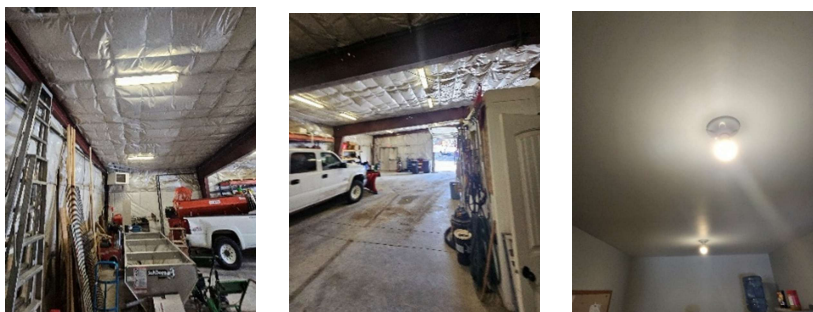
The building's lighting system consists primarily of surface-mounted fixtures and is controlled by a wall-

mounted switch located at the entrance. Based on visual observation, the lights appear to be operational. However, some lights show variation in light output due to dust buildup on the lens cover. The surface-mounted fixtures appear to be T8 fluorescent lights. It is important to note that starting January 1, 2026 the import and manufacture of Linear Fluorescent Lights are prohibited in Canada under the Products Containing Mercury Regulations.

**Figure 62: Public Workshop Lighting**

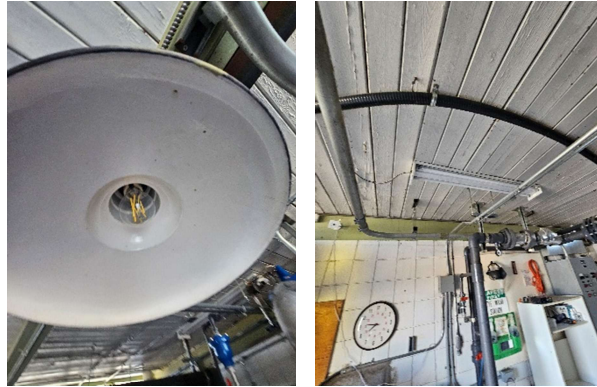
The fire pump building lighting system is a mix of A19 LED bulbs and T8 fluorescent lights. Lighting within the space is controlled manually via a wall-mounted switch located adjacent to the entrance. Based on observation, all luminaires appear to be operational at the time of review. However, there are variations in the light outputs with some of the fixtures showing reduced lumen levels and inconsistent illumination.

**Figure 64: Fire Pump Building Existing Lighting**

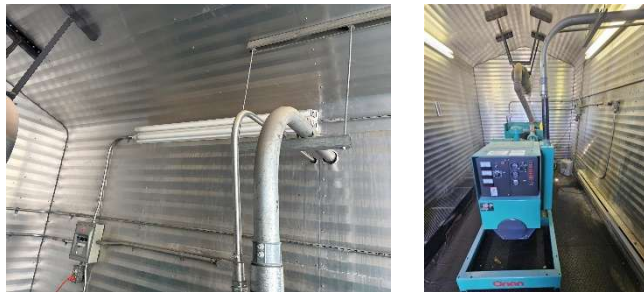
The Generator Building lighting system consists of T8 Fluorescent lighting and is manually controlled by a switch at the front entrance. Based on visual observations, the light appears to be operational. However, there are signs of aging including lamp discoloration and lumen output depreciation. In addition, there is a dust buildup in the fixture, indicating that the lights are not being properly maintained.

**Figure 65: Generator Walk-in Enclosure Lighting**

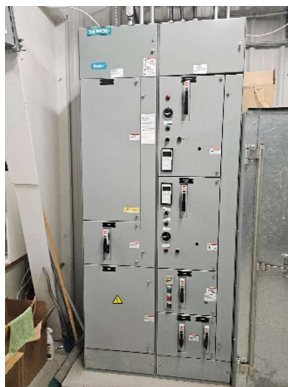
This building houses the Motor Control Center which houses a panel, 15kVA transformer, pumps motor starters. The MCC appears to be installed in 2012. Based on observation, the equipment appears to be in a good working condition with no visible damaged.

**Figure 66: Motor Control Center**

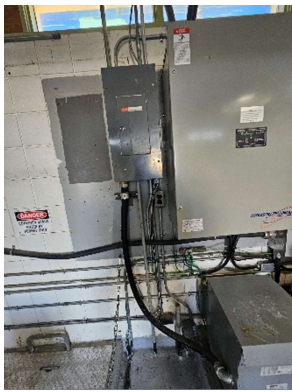
Figure 68: Utility Meter and Main Disconnect

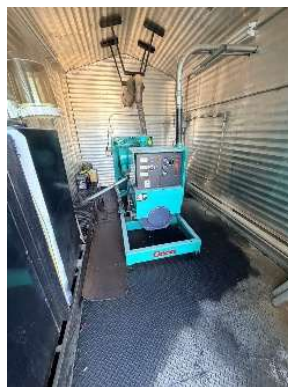
The generator is an ONAN generator and appears to be installed in the early 2000s and is rated 125kVA. Based on visual observations, the generator set, including alternator, engine components, and control panel, appears to have no visible signs of major physical damage. The equipment shows typical signs of age and operational wear which includes dirt accumulation and minor corrosion. It appears that the generator was last tested in 2023.

Figure 71: Existing Generator

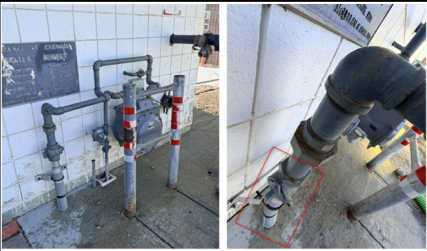
| Section 2 | Item | Rating | Risk Factor | Photo | Bldg. Section | Description/Condition | Estim. Cost |
|---|---|---|---|---|---|---|---|
| 2.1.4 | Gas Service | 3 | Urgent | | Exterior | <p>The main natural gas service at the bulk water distribution building rises from below grade and appears to be in good condition, with steel bollard protection in place. Surface corrosion and weathering on exterior gas piping and valves should be cleaned and repainted to extend service life and maintain corrosion resistance.</p> <p>At the public works shop &amp; WTP Building, the 50 mm (2") natural gas supply for the building rises from below grade and enters through the wall to serve the gas-fired unit heaters and water heater. While currently in good condition, localized corrosion should be addressed through cleaning and repainting where required.</p> | \$ 10,000.00 |

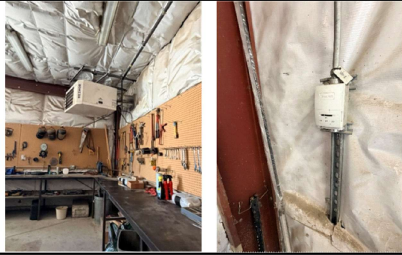
| Section 2 | Item | Rating | Risk Factor | Photo | Bldg. Section | Description/Condition | Estim. Cost |
|---|---|---|---|---|---|---|---|
| 2.2.1 | Gas-fired Unit Heaters (UH-1, UH-2) | 4 | Low | | Public Works Shop | Heating in the public works shop is provided by two (2) gas-fired unit heaters (UH-1, UH-2). The units are Reznor UDAS150-S, at 150,000 Btu/hr (44 kW) input and 124,000 Btu/hr (36 kW) output. The units exhibit minor surface wear and discoloration consistent with normal age and use. Based on a typical service life of 30 years, the units have an estimated remaining service life of approximately 16 years. Replacement is recommended within this timeframe. | \$ 20,000.00 |

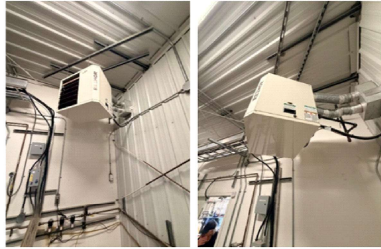
| Section 2 | Item | Rating | Risk Factor | Photo | Bldg. Section | Description/Condition | Estim. Cost |
|---|---|---|---|---|---|---|---|
| 2.2.2 | Gas-fired Unit Heaters (UH-3) | 4 | Low | | Water Treatment Plant | Heating in the WTP is provided by a gas-fired unit heater (UH-3). The equipment is a Reznor unit. However, the make and model could not be confirmed. The unit appears to be in good condition and was installed in 2012. The unit has an estimated remaining service life of approximately 16 years, based on a typical service life of 30 years. Replacement is recommended within this timeframe. | \$ 10,000.00 |

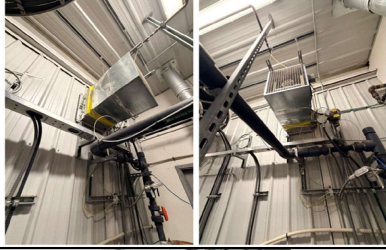
| Section 2 | Item | Rating | Risk Factor | Photo | Bldg. Section | Description/Condition | Estim. Cost |
|---|---|---|---|---|---|---|---|
| 2.2.6 | Exhaust Fan Complete with Motorized Damper | | | | Water Treatment Plant | Exhaust for the WTP is provided by a wall-mounted exhaust fan equipped with a 356x356mm (14x14") motorized damper (DM-101) installed in 2012. The make and model could not be identified, as the units' nameplate are not visible. Overall, the units appear to be in good condition. Based on a typical service life of 30 years, the units have an estimated remaining service life of approximately 16 years. Replacement is recommended within this timeframe. | \$ 10,000.00 |
