# **VILLAGE OF CREMONA**

## **OLD UNITED CHURCH - BUILDING CONDITION ASSESSMENT**

**Date: May 8, 2026**

**Project #: 2490-019-01**

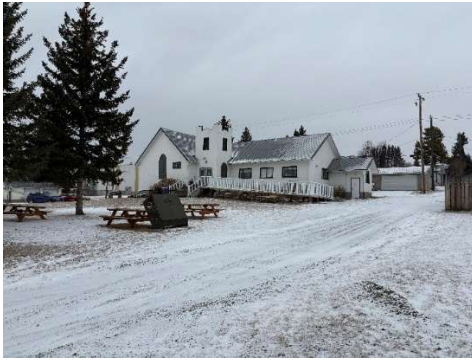
**Figure 6: Southeast Corner of Site**

The site around the four sides of the building is grass. On the north and east sides of the building, there is a gravel road about 3m (9.8') away from the building walls. General grading to the east and south of the building is sloped away from the building foundation. The grading to the north and west of the building is relatively flat. Various concrete walkways are located around the building site. The walkways are generally in fair condition with some minor cracking. The front stair concrete on the south side of the building is in poor condition with surface cracking and popouts along with visible cracking on the side of the concrete

stairs. If left in their current state, ongoing moisture infiltration and freeze-thaw exposure may contribute to continued deterioration of the stair and walkways.

A drainage evaluation is recommended to determine if the site grading is performing as expected. This can be achieved by observing surface flow during a rainfall event and locating areas where pooling is still present following the event. Alternatively, an evaluation may be artificially generated by applying a large amount of water to the surface (typically using a fire hose), observing surface flow, and locating areas where pooling is present; however, cost should be considered before this alternative method is used. Once the drainage analysis has been completed, it is recommended to regrade in the remaining ponding areas.

Concrete cracks, popouts, and other deterioration around the site and on the flat and vertical stairway surfaces should be patched and repaired using an exterior grade patching compound. This is intended to reduce the potential for further deterioration associated with moisture intrusion and freeze-thaw exposure.

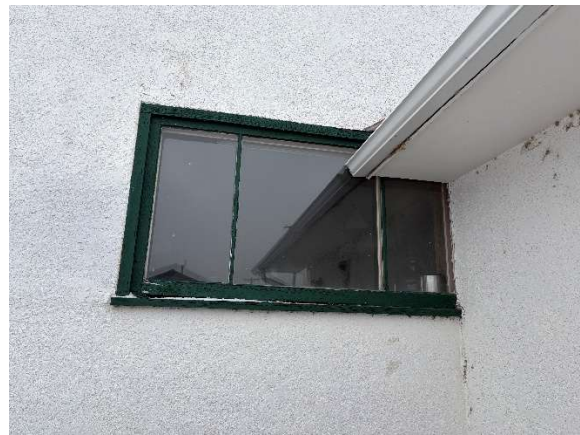
The exterior doors, door frames, and weather stripping are in fair to poor condition. There is some paint deterioration on the door surfaces and on the door frames. The handle on the southeast main door has some rust staining. Weather stripping throughout the exterior doors is worn out as some daylight can be seen around the door perimeters from the building interior. The windows and window frames appear to be worn out and due for replacement from both the interior and exterior of the building. The glass is faded and the frame paint is fading. A south face basement window is installed without proper flashing, exposing the spray foam insulation beneath. This can result in moisture penetrating the building envelope and causing moisture related damage like rotting and insulation saturation. These window and door concerns result in poor building energy performance.

**Figure 15: Worn Out Window**

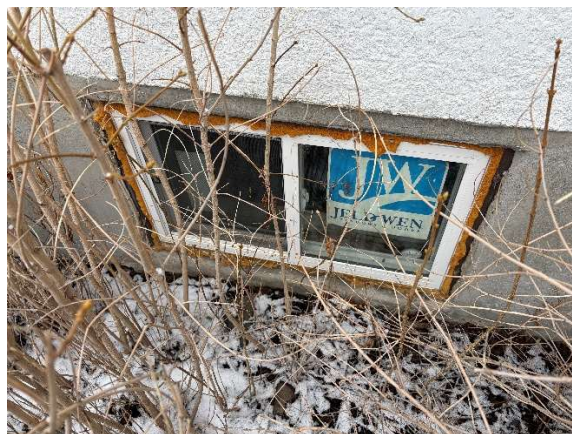
**Figure 16: Exposed Spray Foam Insulation Around Window**

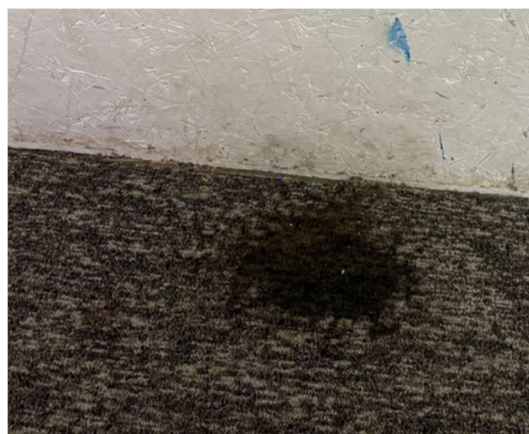
The wall drywall has numerous scuffs and abrasions throughout the building. The wall paneling is faded and moisture stained in many instances. Overall, the interior wall finishes are in fair to poor condition. The carpet on the main floor of the building is generally in fair condition with minor staining and no visible signs of fraying. The newly installed linoleum faux hardwood flooring in various main floor rooms is in good condition. The laminate tile flooring in the main floor kitchen is in poor condition with substantial staining and some penetrations. In the basement, carpet is installed directly on top of the slab-on-grade in many rooms. This is poor practice as any moisture that leaks through slab cracks will be trapped in the carpet, rather than handled by a sub flooring material. As a result, the basement carpets are in poor condition with staining and fraying across large portions of the surface. These issues can result in building odour and mold.

**Figure 23: Stained Carpet**

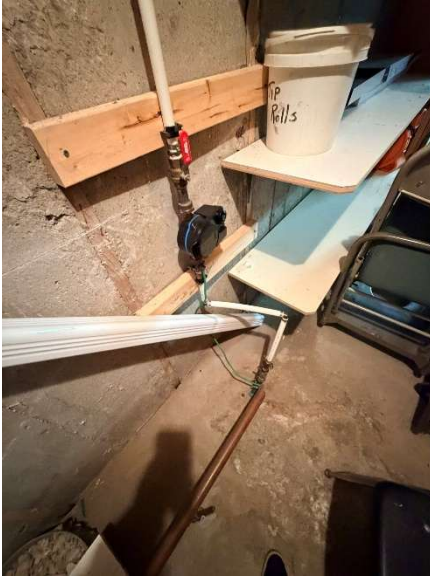
**Figure 31: Water Service**

water service cannot be assumed to match the building's construction, as PVC water services were not introduced until the 1980s. While the visible portion appears to be in good condition, the age of the water service cannot be determined. As such, the water service should be inspected to assess the condition of the below-grade piping and to determine whether replacement may be required in the near future. In addition, the domestic water service does not appear to be equipped with a backflow preventer. In accordance with the National Plumbing Code, potable water connections to plumbing fixtures must be arranged to prevent backflow.

The domestic water distribution lines and valves are 'L' hard drawn copper. Due to the lack of record drawings, the age of the domestic water distribution system cannot be confirmed. Domestic water piping systems typically have an expected service life of approximately 50-70 years, and if the existing distribution piping was installed between 1956-1976, it may be approaching or exceeding its anticipated service life. The distribution system be further evaluated to assess its overall condition and determine whether partial or full replacement is required.

In addition, it was observed that the domestic hot water piping associated with the water heater is not insulated. It is recommended that thermal insulation be installed on exposed hot water piping to improve energy efficiency, reduce heat loss, and enhance system performance.

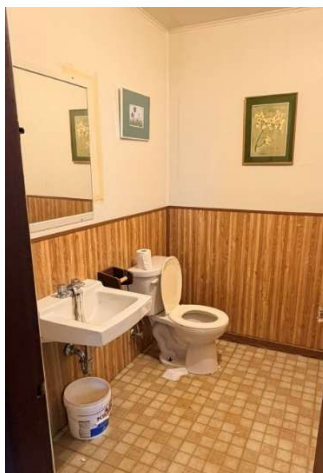
In one of the washrooms in the basement, the wall-mounted lavatory exhibits significant black staining beneath the faucet spout, which is consistent with long-term leakage. A bucket was also observed beneath the lavatory, indicating active leakage. Although the fixture appears to be intact, repair or replacement of the faucet, along with cleaning of the lavatory, is recommended to restore proper condition and functionality.

**Figure 34: Basement Washroom  
Fixtures**

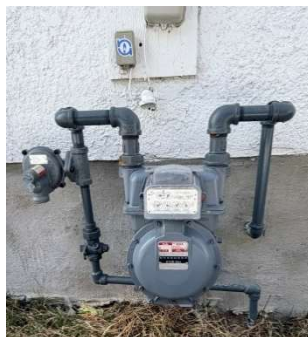
The main 25 mm (1") natural gas service enters the building at the southeast corner and supplies gas-fired furnaces and the domestic water heater. The natural gas service piping appears to be in generally acceptable condition. However, minor corrosion was observed on portions of the piping. It is recommended that any corroded or unpainted sections of the gas piping be cleaned and repainted to help reduce the risk of further corrosion and deterioration.

**Figure 36: Gas Meter & Regulator SE of Building**

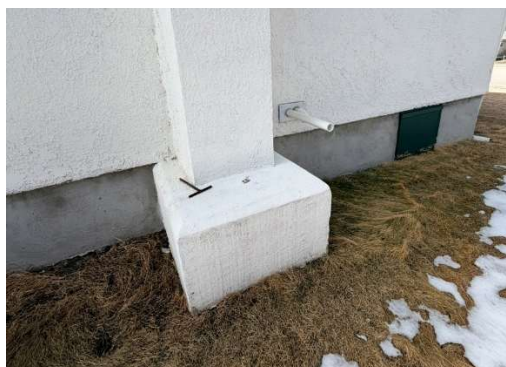
The venting for the furnace and domestic water heater is through wall. These vents appear to be in good condition and are functioning as intended.

**Figure 37: Venting**

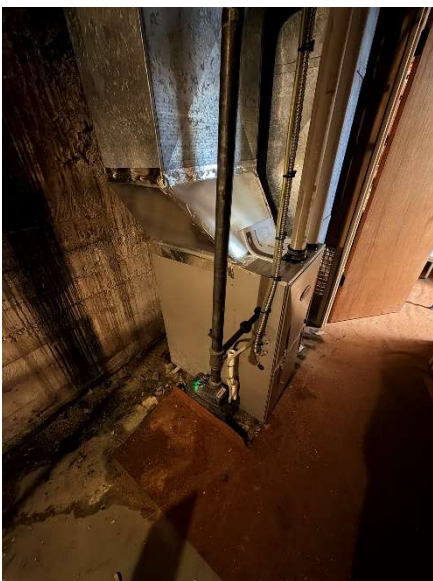
The building is primarily heated by two (2) gas-fired furnaces. One is a Carrier unit, 59SC5B080E171116 with a 78,000 Btu/hr (23 kW) output, and installed in October 2020. Gas-fired units have a typical service life of 15-20 years, so the unit has 14 years of remaining service life. The furnace is equipped with a condensate pump that is installed on the floor. Both the furnace and the condensate pump appear to be in good condition. However, signs of water intrusion were observed on the wall behind the furnace. Debris is also present on the floor in the furnace area, and the lower portion of the furnace and the condensate pump shows signs of moisture exposure. This exposure may compromise the integrity of the furnace and contribute to corrosion of its metal components. To mitigate this risk, the furnace should be installed on a housekeeping pad to protect it from potential minor flooding in the area.

**Figure 38: Carrier Furnace in Basement**

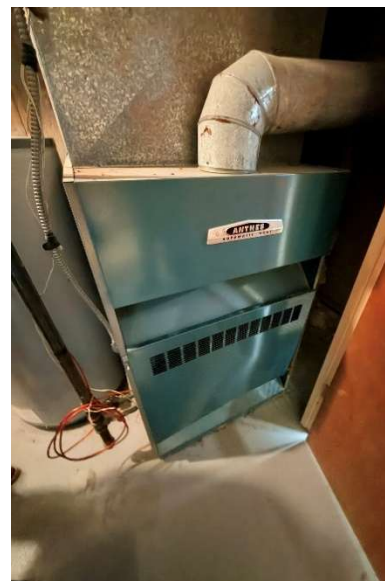
The second furnace is an Anthes Automatic Heat unit. The unit does not have a nameplate, so the model and capacity of the unit cannot be determined. Labels on the unit indicate that the filter was last replaced in August 2014 and that the ¼ hp (0.20 kW) furnace motor was replaced on November 30, 2012. Gas-fired furnaces typically have a service life of approximately 25 to 30 years. The newer Carrier unit is estimated to have approximately 24 years of remaining service life. The older Anthes unit, with a motor replacement, is estimated to have approximately 16 years of remaining service life. The furnace filter in the Anthes unit appears to be overdue for replacement. Filters should generally be replaced every 6 to 12 months. Replacement of the filter is recommended.

**Figure 40: Anthes Furnace in Basement**

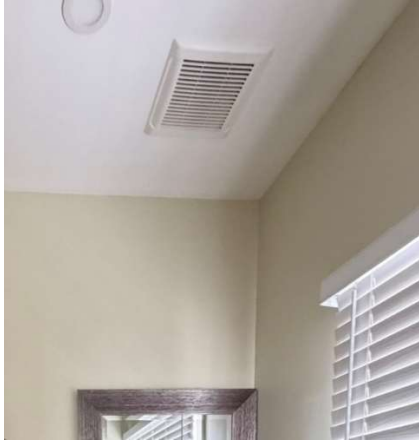
Exhaust for the washrooms is provided by a ceiling-mounted exhaust fan. The kitchenette stove is not equipped with a dedicated range hood, and the exhaust ventilation is provided by a wall-mounted exhaust fan. The installation date of the exhaust fans could not be verified. Based on visual observation, the fans appear to be in good operating condition and functioning as intended. However, given a typical service life of approximately 25 years, it is recommended that the exhaust fans be replaced if they were installed prior to 2001.

**Figure 41: Typical Washroom Exhaust Fan**

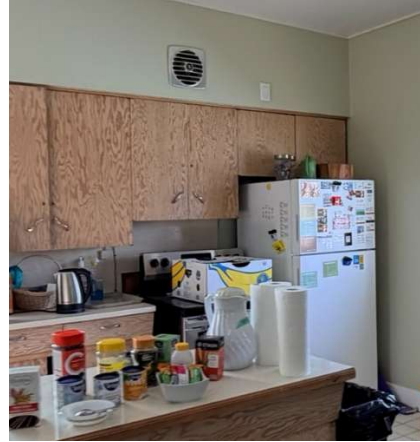
**Figure 42: Wall-mounted Exhaust Fan Above Range Cooker**

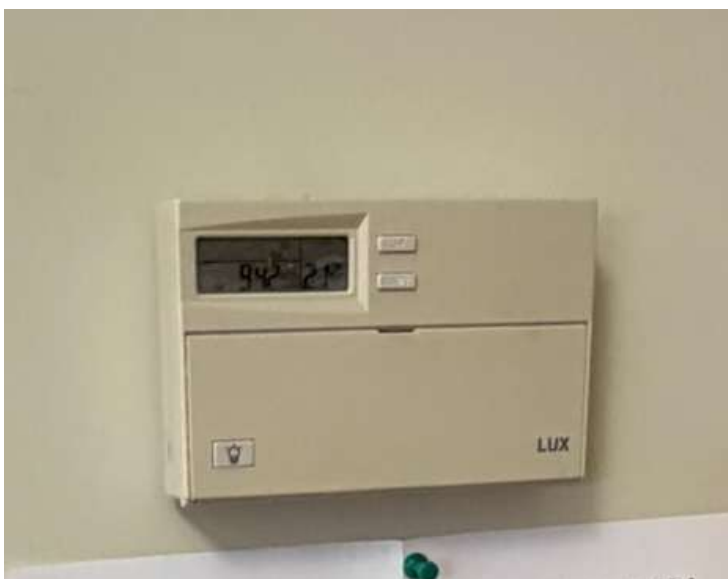
The installation dates of the thermostats are likely the same as those of their respective furnaces. However, the installation date of the older LUX thermostat cannot be determined, as the installation date of the Anthes furnace is also unknown. Although the thermostats are currently in good condition, the LUX unit should be monitored for signs of inefficiency, such as inaccurate temperature readings, unresponsiveness, or failure to communicate with the furnace. If any of these issues arise, it should be replaced with a newer programmable thermostat.

**Figure 46: LUX Programmable Thermostat**

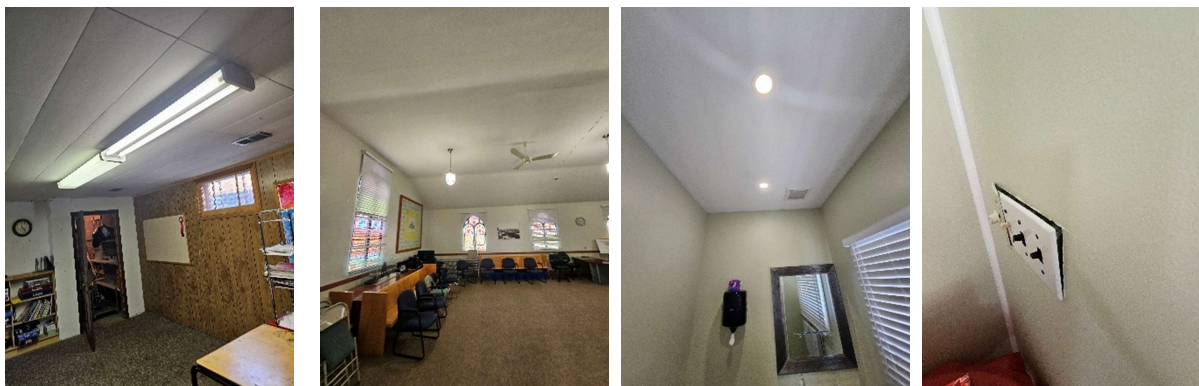
Based on observation, the decorative pendant and recessed pot lights appear to be in good condition. On the other hand, the fluorescent lights installed in the basement appear to have a mix of different lumen outputs, which might be due to partial lamp or fixture replacements over time, resulting in a mix of different lamp types, ages, and colour temperature. This condition creates uneven illumination levels.

The main floor lighting is controlled using the manual switches located near the main entrance vestibule, which appear not to be properly flush with the wall. The basement corridor lighting is controlled by

**Figure 50: Existing Lighting System**

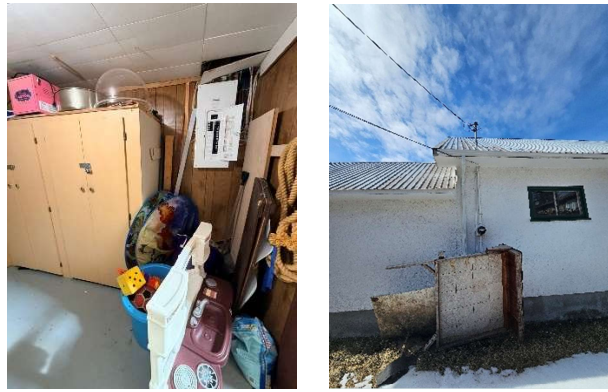
The building is fed from a Fortis Utility Transformer mounted on the utility pole and a utility meter located on the exterior of the building. The main panel is located in the basement. The panel appears to be new, and no visible damage was observed. The panel appears to be partially obstructed by stored materials and miscellaneous items directly in front of the panel. Similarly, broken tables are stored in front of the utility meter.

Figure 52: Existing Panel and Utility Meter
